**Punch Taverns
203284 | Rusty Dudley
43-45 Doncaster Road
Goldthorpe
Rotherham
UK**

CONDITION SURVEY

27 April 2018

Gleeds
Wilford House
1 Clifton Lane
Wilford
Nottingham
NG11 7AT

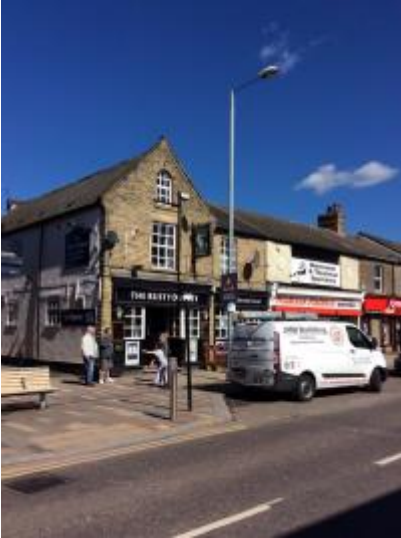
<p>Section: 01.01. PUB FRONTAGE</p> <p>Element: 1.1. Foundations & Structure /</p> <p>Description: General condition of external structure</p> <p>Grade: 3 - Good</p> <p>Priority: Year 6+</p> <p>Action: None</p> <p>Defect:</p> <p>Scope of Works:</p> <p>Location: Frontage</p>

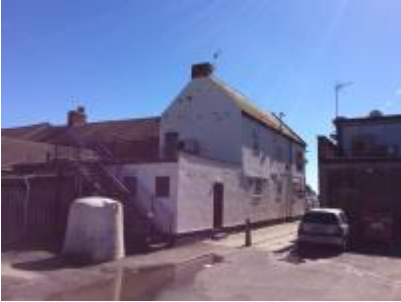
<p>Section: 01.02. EXTERNALS</p> <p>Element: 1.1. Foundations & Structure /</p> <p>Description: General condition of external structure</p> <p>Grade: 3 - Good</p> <p>Priority: Year 6+</p> <p>Action: None</p> <p>Defect:</p> <p>Scope of Works:</p> <p>Location: Externals</p>

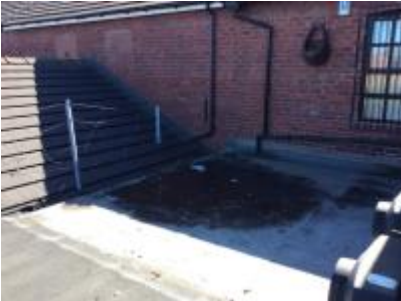
<p>Section: 01.02. EXTERNALS</p> <p>Element: 2.6. Roof Coverings /</p> <p>Description: Flat - single ply membrane</p> <p>Grade: 2 - Satisfactory</p> <p>Priority: Years 1-5</p> <p>Action: Repair</p> <p>Defect:</p> <p>Scope of Works: Ponding on flat roof may attribute to internal leaks?</p> <p>Location: Rear flat roof</p>

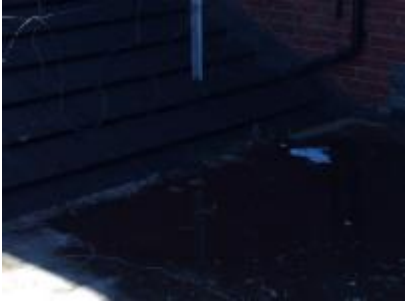
<p>Section: 01.02. EXTERNALS</p> <p>Element: 2.8. Roof Drainage /</p> <p>Description: uPVC gutters and downpipes</p> <p>Grade: 2 - Satisfactory</p> <p>Priority: Years 1-5</p> <p>Action: Repair</p> <p>Defect:</p> <p>Scope of Works: Clear gutters of vegetation</p> <p>Location: Rear flat roof</p>

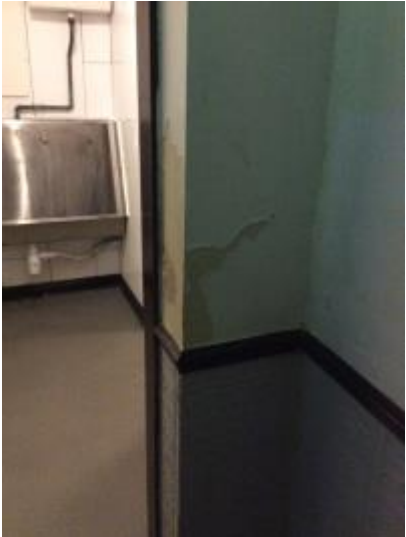
<p>Section: 02.10. TRADE AREA – GENTS TOILETS</p> <p>Element: 3.1. Wall Finishes /</p> <p>Description: Decoration generally</p> <p>Grade: 2 - Satisfactory</p> <p>Priority: Years 1-5</p> <p>Action: Repair</p> <p>Defect:</p> <p>Scope of Works: Redecorate plastered walls in toilet lobby</p> <p>Location: Toilet lobby</p>

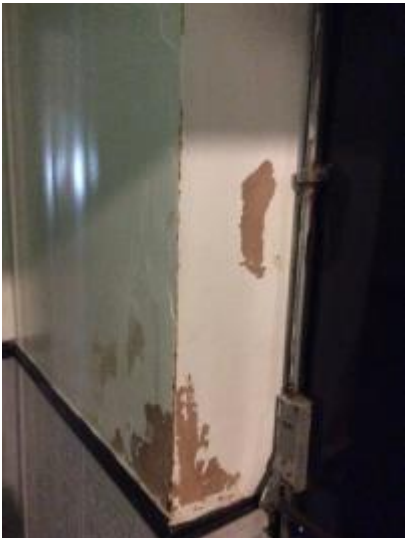
<p>Section: 02.10. TRADE AREA – GENTS TOILETS</p> <p>Element: 3.1. Wall Finishes /</p> <p>Description: Decoration generally</p> <p>Grade: 2 - Satisfactory</p> <p>Priority: Years 1-5</p> <p>Action: Repair</p> <p>Defect:</p> <p>Scope of Works: Redecorate plastered walls in toilet lobby</p> <p>Location: Toilet lobby</p>

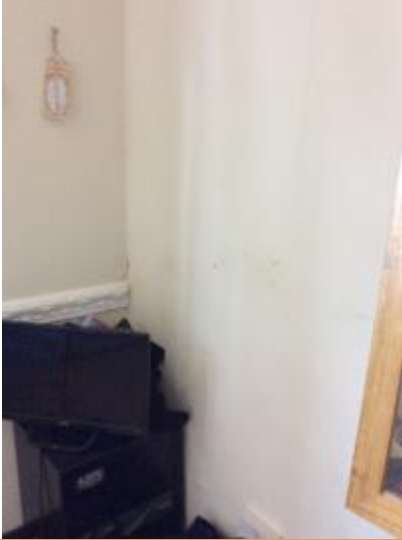
<p>Section: 03.05. DOMESTIC ACCOMMODATION - BEDROOM 3</p> <p>Element: 3.1. Wall Finishes /</p> <p>Description: Decoration generally</p> <p>Grade: 2 - Satisfactory</p> <p>Priority: Years 1-5</p> <p>Action: Repair</p> <p>Defect:</p> <p>Scope of Works: Rear wall showing damage from water ingress</p> <p>Location: Rear wall of domestic bedroom 3</p>

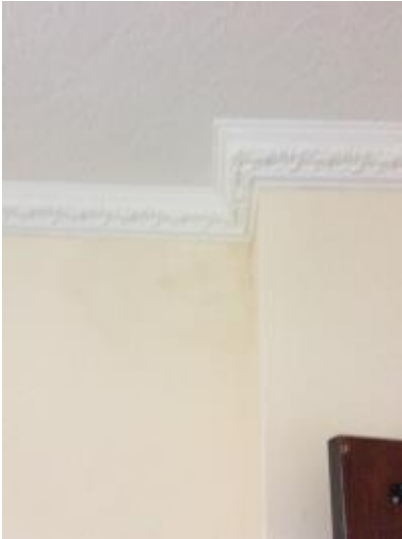
<p>Section: 03.05. DOMESTIC ACCOMMODATION - BEDROOM 3</p> <p>Element: 3.1. Wall Finishes /</p> <p>Description: Decoration generally</p> <p>Grade: 2 - Satisfactory</p> <p>Priority: Years 1-5</p> <p>Action: Repair</p> <p>Defect:</p> <p>Scope of Works: Rear wall showing damage from water ingress</p> <p>Location: Rear wall of domestic bedroom 3</p>

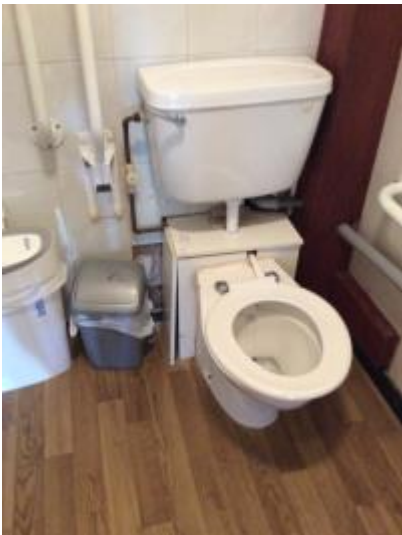
<p>Section: 02.12. TRADE AREA – DISABLED TOILETS</p> <p>Element: 3.1. Wall Finishes /</p> <p>Description: Ceramic tiles</p> <p>Grade: 2 - Satisfactory</p> <p>Priority: Years 1-5</p> <p>Action: Repair</p> <p>Defect:</p> <p>Scope of Works: Tiles have come away</p> <p>Location: Easy Accessible Toilet</p>

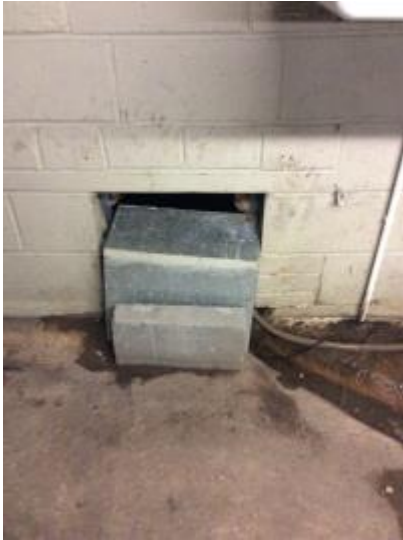
Section: 04.05. CELLAR

Element: 4.1. General Fittings, Furnishings and Equipment
/

Description: Fixed shelving

Grade: 2 - Satisfactory

Priority: Years 1-5

Location: Cellar

Action: Repair

Scope of Works: Refix metal gully cover
