Schedule of Condition

Property Address:	The Crown The Street Eythorne, Dover CT15 4BG	
Outlet Number:	122943	
Document Reference:	N/A	Rev. Year 0
Document Date:	31st May 2018

In accordance with instructions received from Punch Taverns, Romans Surveyors and Valuers have carried out an inspection of the subject premises to report on the condition of the premises in connection with the proposed leasehold interest.

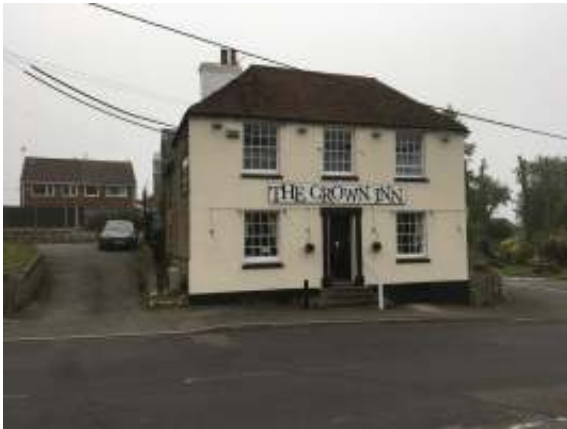
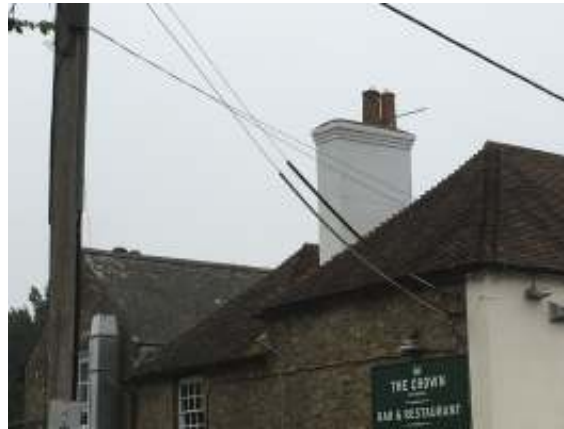
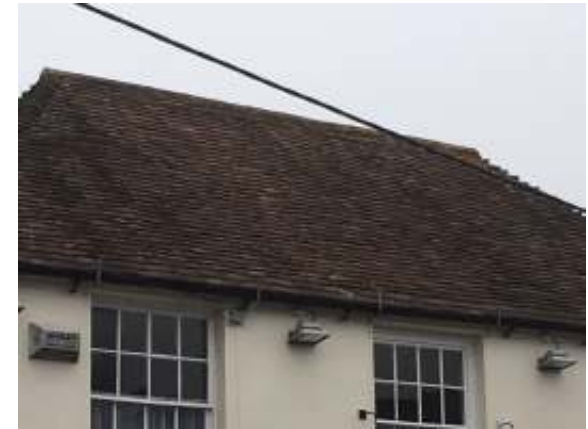
1.1	Front elevation		Photographs [2-4]					
1.1.1	Chimney	Rendered masonry chimney with two clay pots and, masonry paint decoration.	Satisfactory Condition - note that chimney recently repaired and decorated.

1.1.2	Roof	Multiple pitched roofs with plain clay tiles and asbestos artificial slates.	Satisfactory Condition where seen, individual front damaged clay tiles noted and, artificial slates are aged and asbestos based.

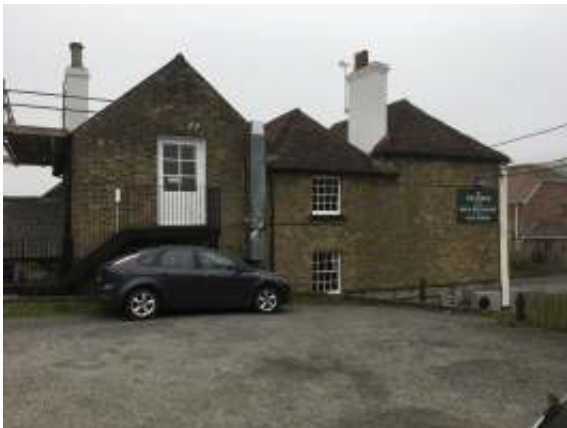
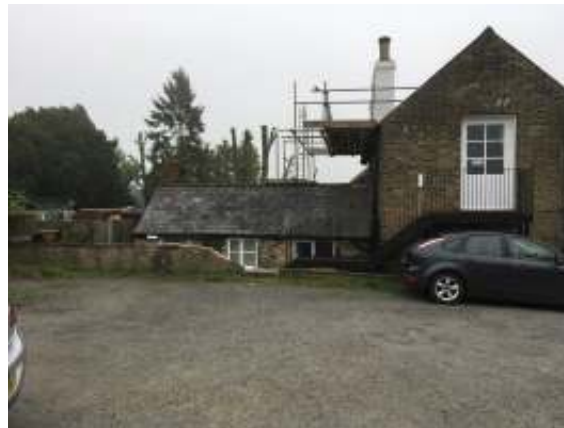
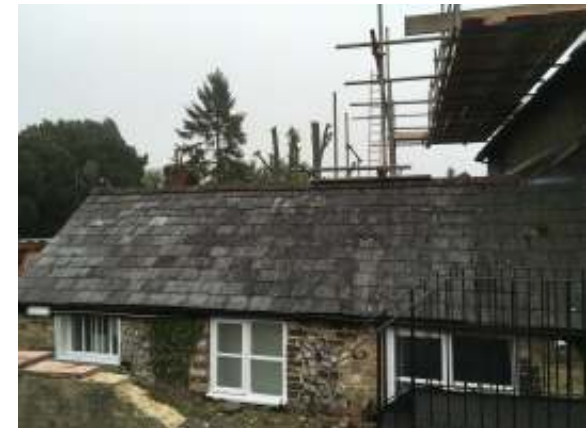
1.2	Left side elevation		Photographs [5-7]					
1.2.1	Roof	Multiple pitched roofs with plain clay tile covering, and, natural slate roofing.	Satisfactory Condition - note repairs required to top two courses of slates to rear single storey section. High level valley gutters not seen.

1.2.2	Rainwater Goods	Plastic and painted metal gutters with plastic rainwater downpipe.	Satisfactory Condition - note some vegetation present to gutters.

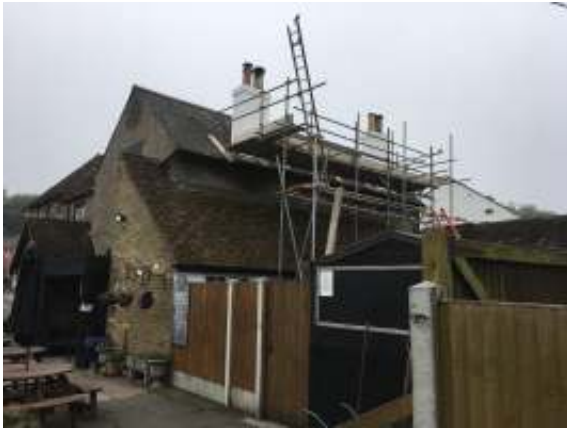
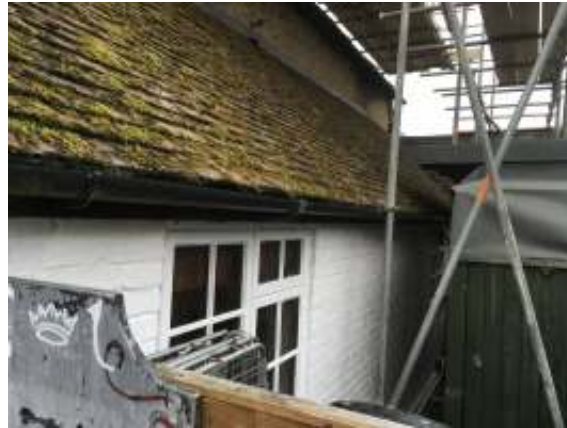
1.3	Rear elevation		Photographs [8-9]					
1.3.1	Chimney	Two brick built chimneys with render and masonry paint decoration including clay pots and lead flashings.	Satisfactory Condition - chimneys recently repaired and, decorated. Please slo note right side chimney has slight tilt.

1.3.2	Roof	Multiple pitched roofs with plain clay tile covering and, asbestos based artificial slates, including lead flashings.	Satisfactory Condition - note moss growth to rear mono pitched roof.

1.3.3	Rainwater Goods	Plastic gutters and downpipes.	Satisfactory Condition - note uneven gutter / short missing downpipe to rear right corner of first-floor roof.

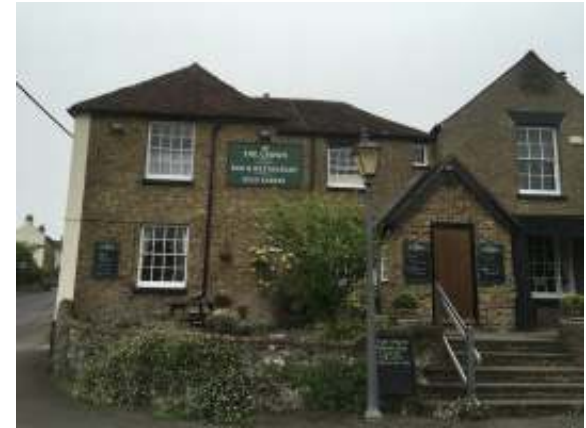
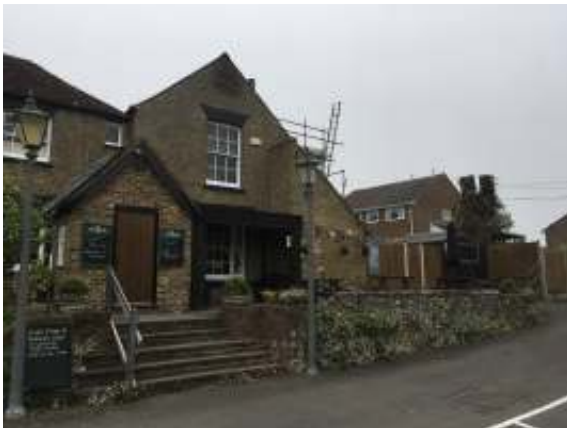
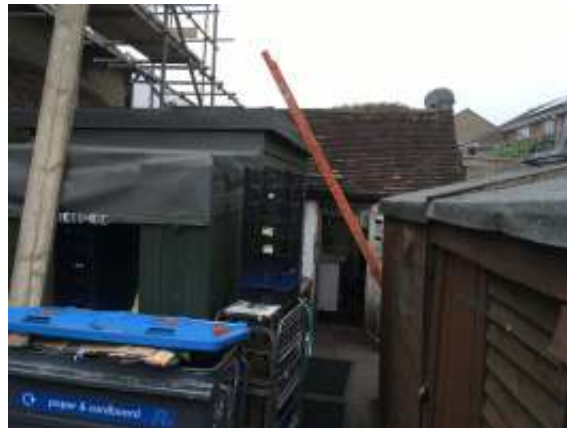
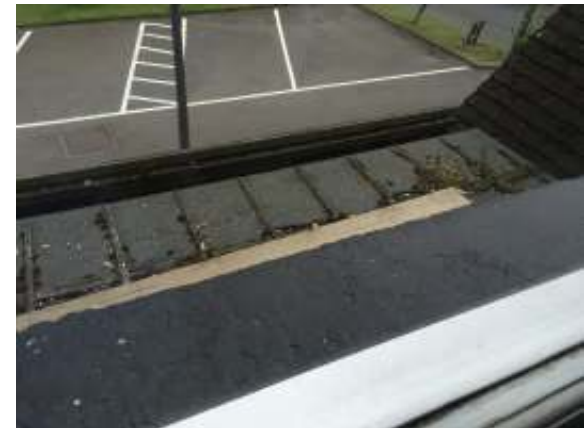
1.4	Right elevation		Photographs [10-13]					
1.4.1	Roof	Multiple pitched roofs with plain clay tile covering and lead flashings, felt roof to timber canopy surround.	Satisfactory Condition - note clay tiling is aged with deterioration to eaves course and, isolated frost damage.

1.4.5	Walls	9" solid and brick faced cavity masonry walls with painted rendered sills.	Satisfactory Condition - note signs of weathering to printing under front most ground floor window.

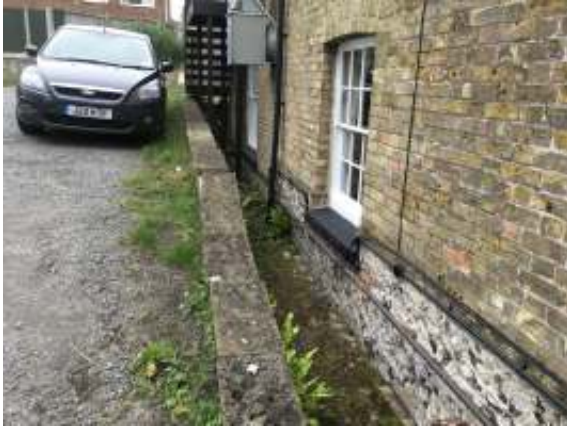
Photo 14

1.5	Grounds to left side of building.		Photographs [14-15]					
1.5.1	General	Make shift mixed aggregate hard standings with rendered masonry boundary wall including concrete cappings.	Poor Condition -

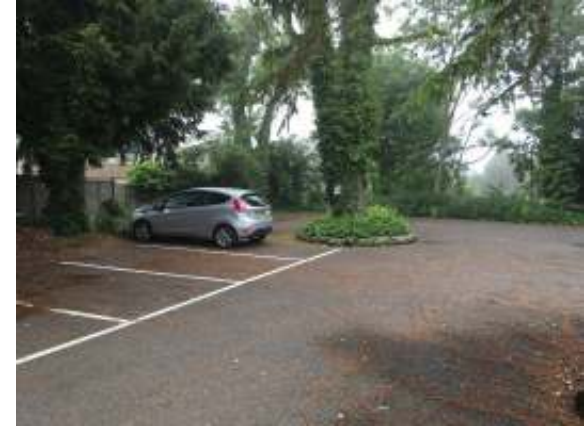
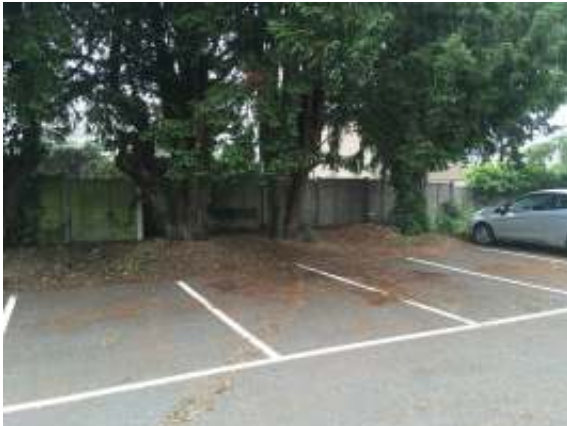
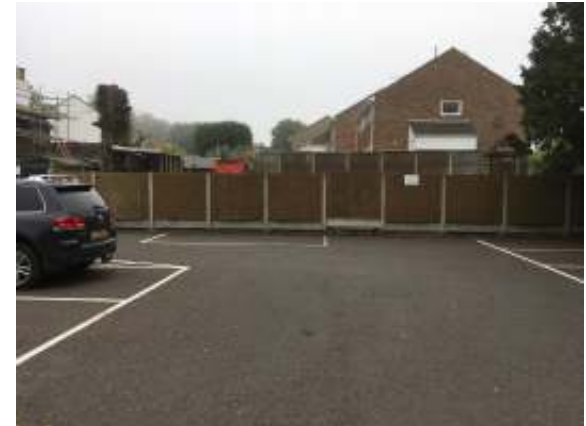
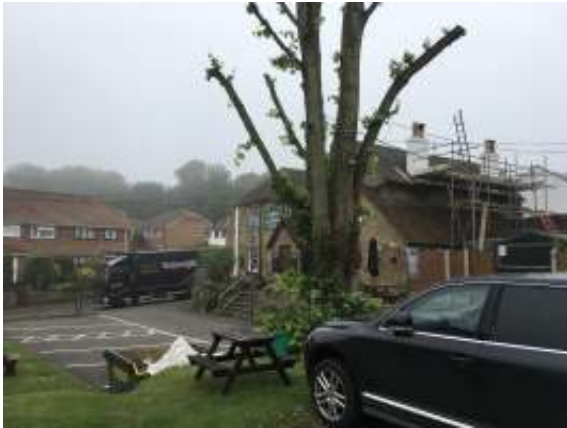
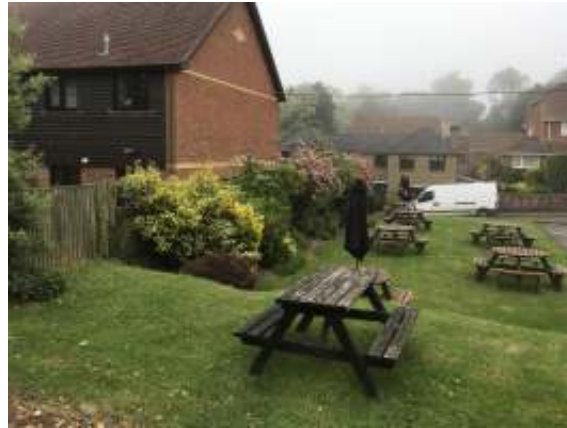
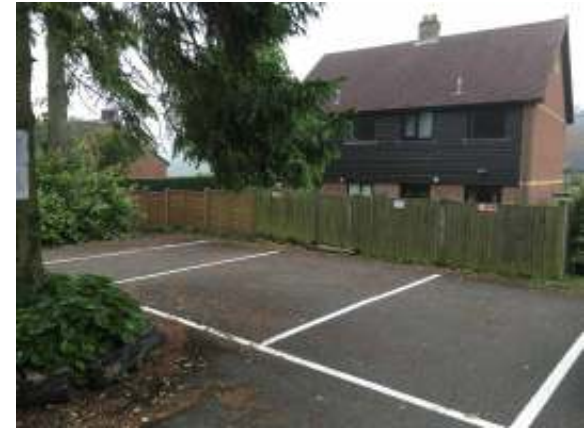
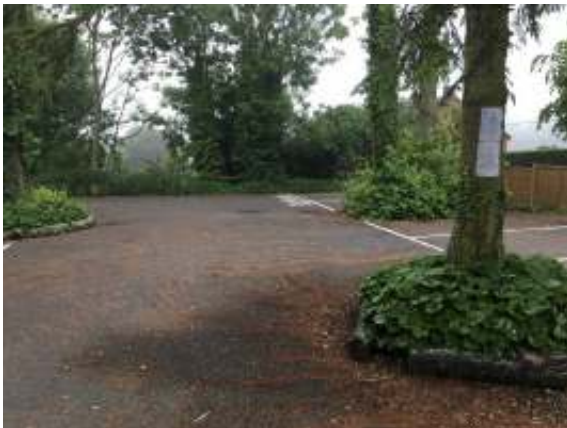
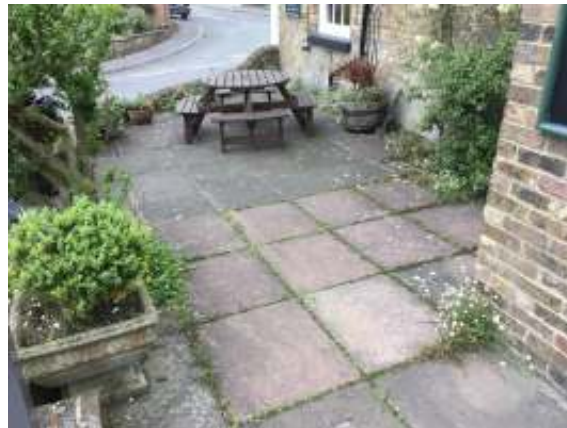
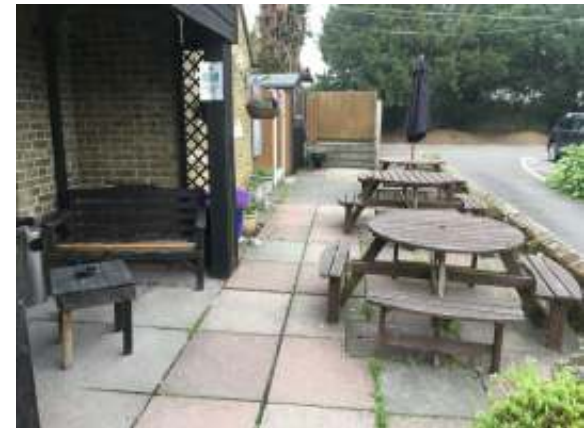
1.6	Grounds to right side of building.		Photographs [16-25]					
1.6.1	General	Tarmac carpark, lawn, border planting and numerous established trees, areas of panel and close boarded timber fencing, flint patio wall, concrete paved patio beer area, and, two feature street lamps.	Satisfactory Condition - please note the tarmac wearing course is starting to breakdown but immediate repairs are not required, and, isolated damage to rear boundary fence. Note also Brocken glazing to the two street lights.

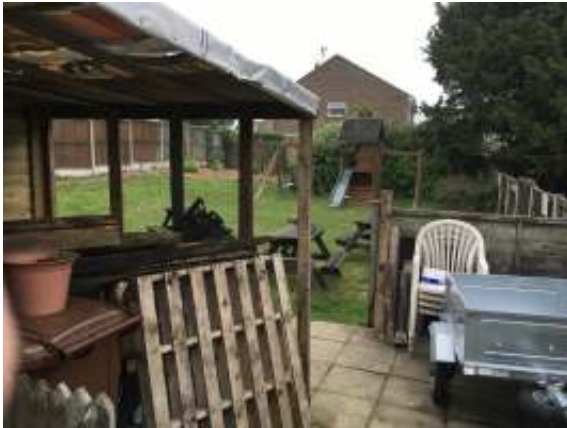
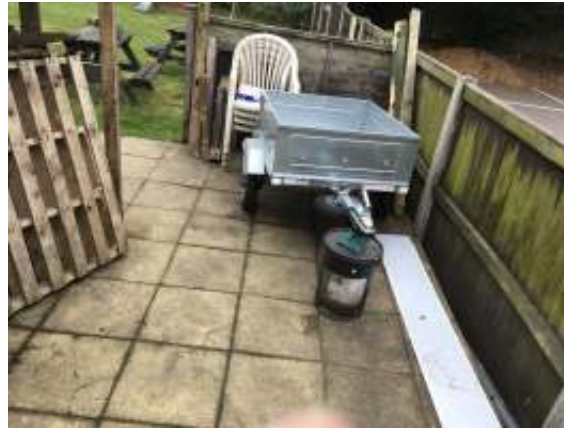
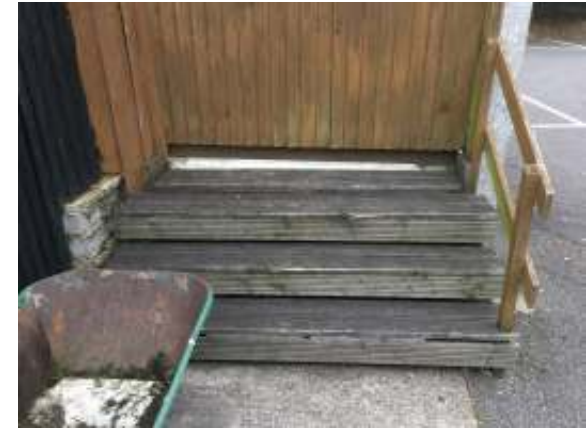
1.7	Rear beer garden		Photographs [26-28]					
1.7.1	General	Mixed timber fencing, lawn, concrete paved patio, isolated border planting, and timber decking steps to car park.	Satisfactory Condition - note mixed condition and incomplete stain finishes.

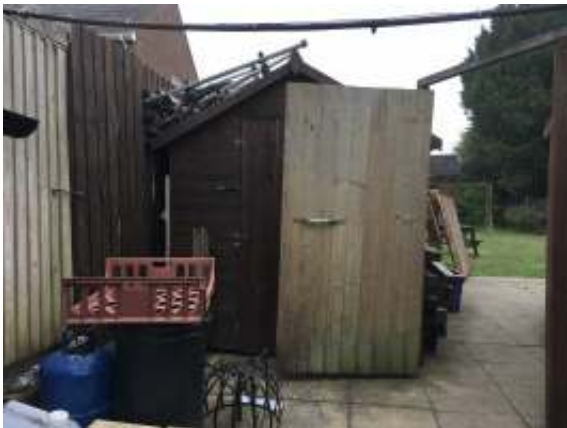
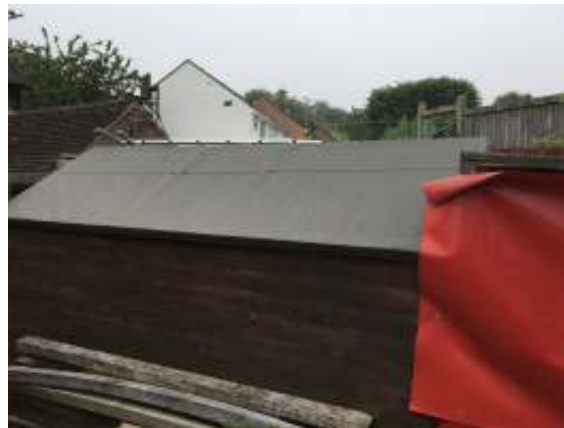
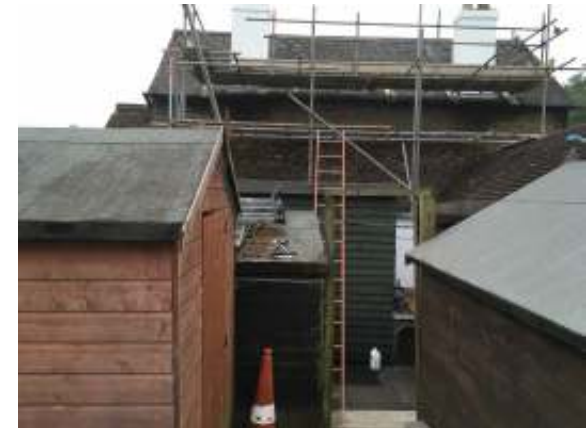
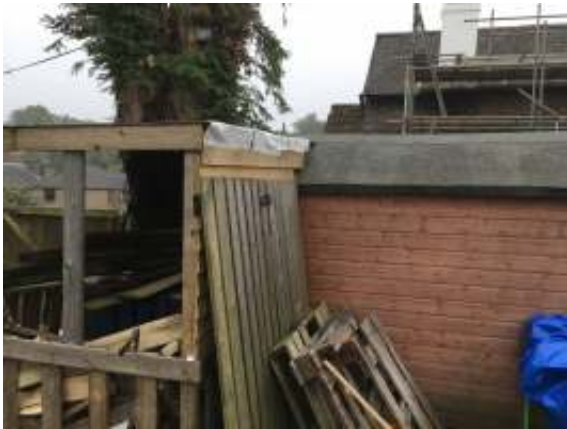
1.8	Rear beer garden sheds		Photographs [29-32]					
1.8.1	General	Mixed timber sheds with felt roof coverings.	Satisfactory Condition - note these are basic short life structures.

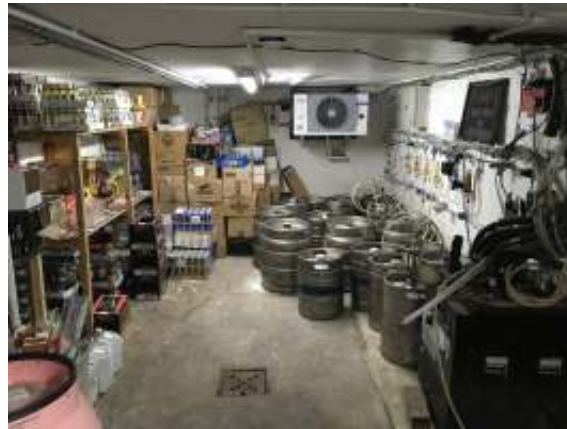
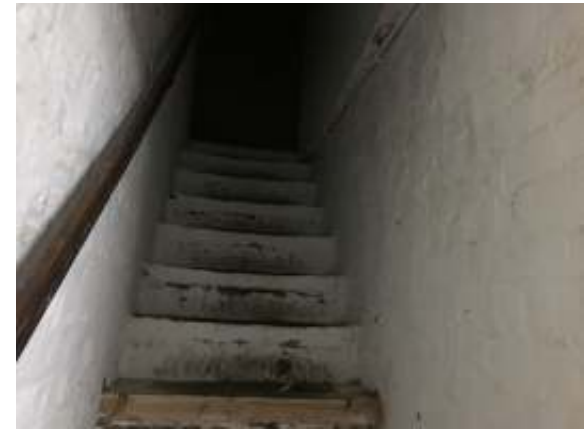
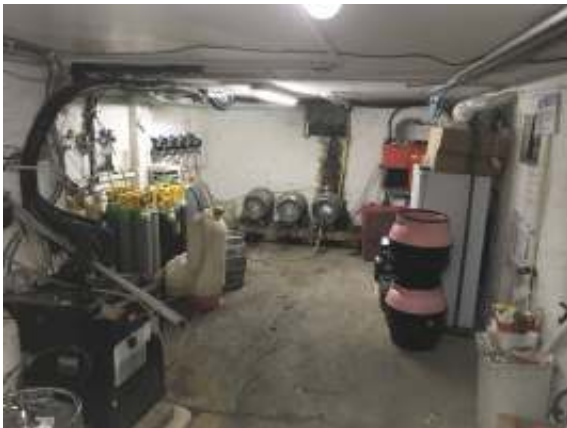
2.9.3	Floors	Exposed concrete floor.	Satisfactory Condition - note Floor is aged and uneven.					
2.9.4	Joinery	Mixed timber doors with paint decoration.	Satisfactory Condition -

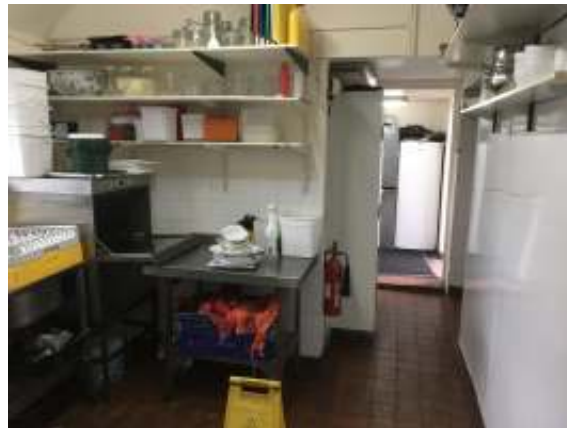
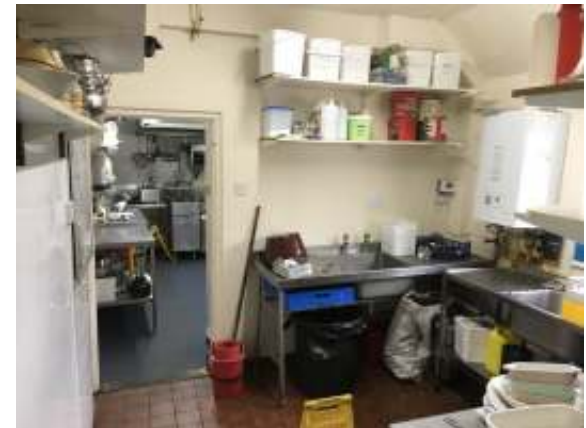
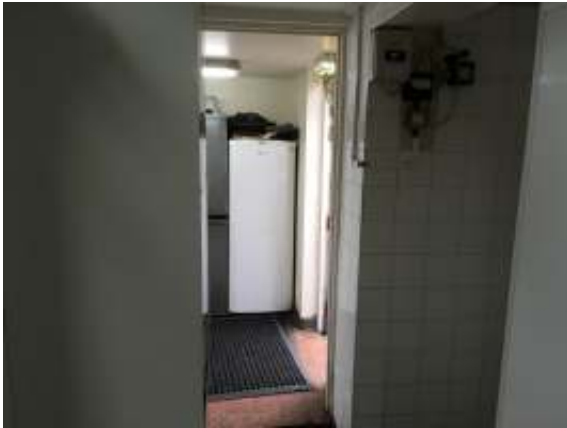
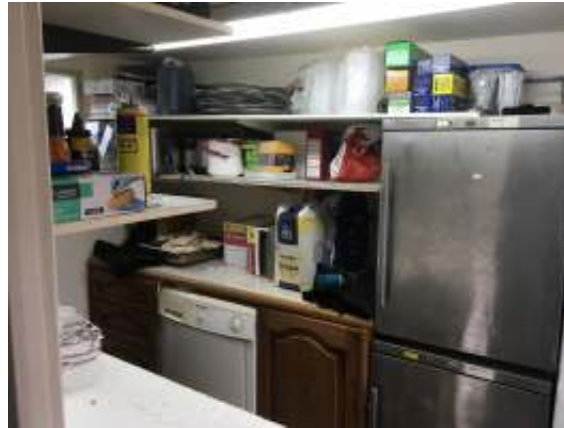
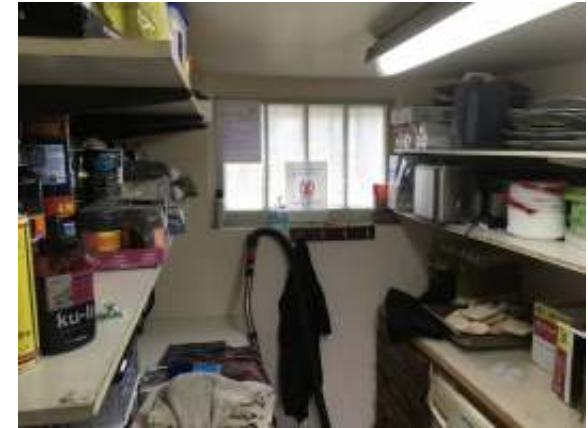
2.10	Ground floor kitchen store and sink area.		Photographs [36-40]					
2.10.1	Ceilings	Painted plasterboard ceiling.	Satisfactory Condition -					
2.10.2	Walls	Masonry walls and partitions with plaster and paint decoration, and ,areas of ceramic tiling and plastic cladding.	Satisfactory Condition - note recently decorated and isolated hollow plaster. Grotty ceramic tiling by centre left sink.

2.10.4	Joinery	Timber doors, door frame, casement windows, all with paint decoration.	Satisfactory Condition - note no decoration to rear kitchen door.

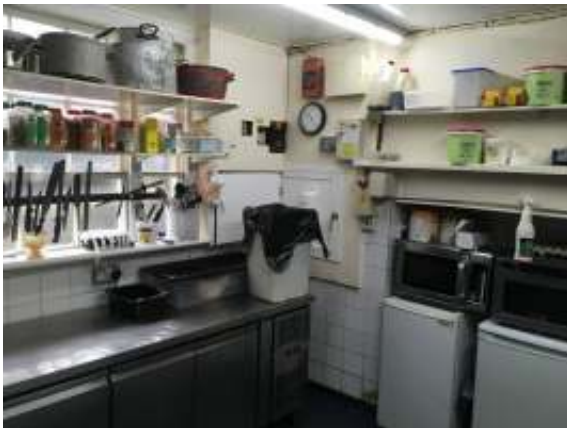
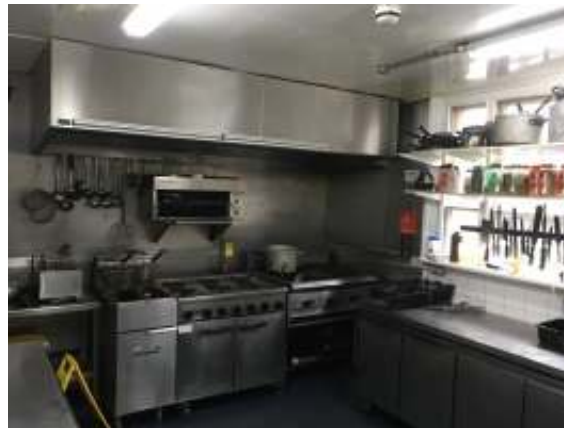
2.11	Ground floor commercial kitchen		Photographs [41-42]					
2.11.1	Ceilings	Plastic clad ceiling.	Satisfactory Condition -					
2.11.2	Walls	Masonry walls and partitions with plaster, ceramic tiles, steel splash backs.	Satisfactory Condition - note some grubby marks to grouting of tiles.

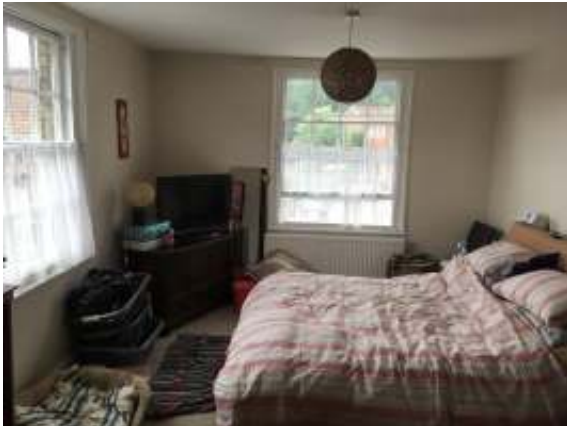
Photo 59

2.16.4	Joinery	Bare timber doors, painted sash windows and skirting boards.	Satisfactory Condition - note no sash cords to right side window and , decoration recently provided.

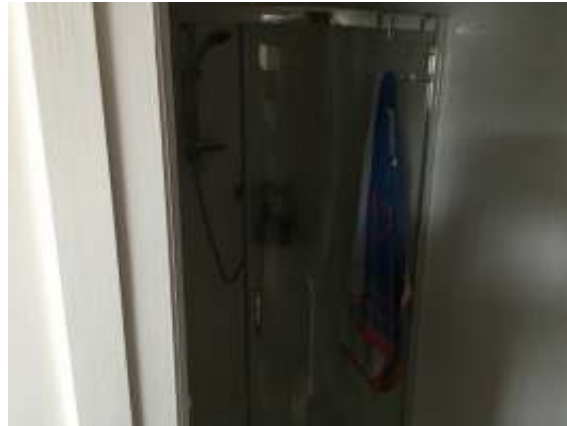
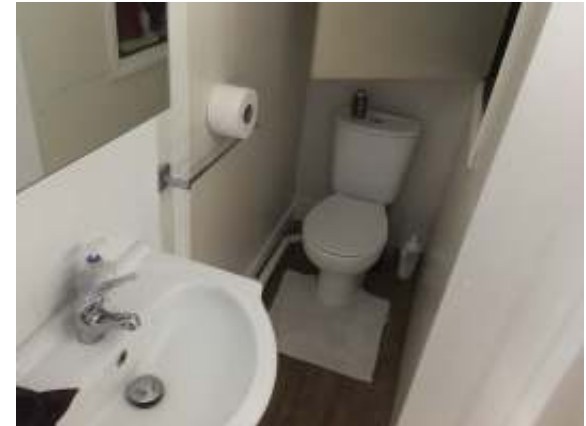
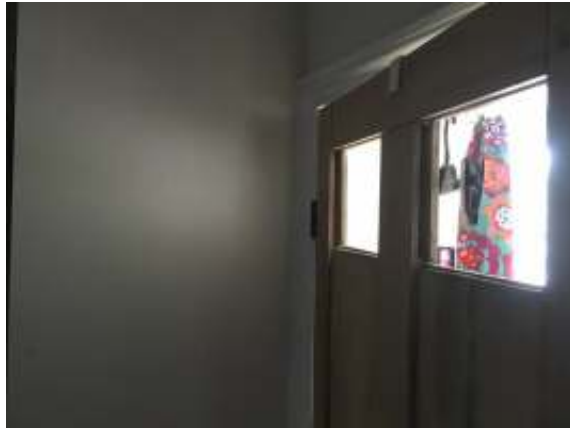
2.17.3	Joinery	Timber door and,skirting boards with modern sink vanity unit.	Satisfactory Condition - note small missing glazed panels to door.					
2.17.4	Miscellaneous	Shower pump and pipework, modern sanitary fittings with safety glass shower screen, bulkhead light, pull cord light switches.	Satisfactory condition although no formal test of these items have been undertaken by us. -

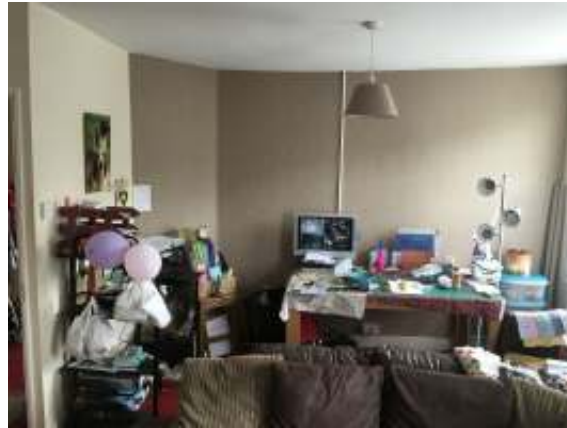
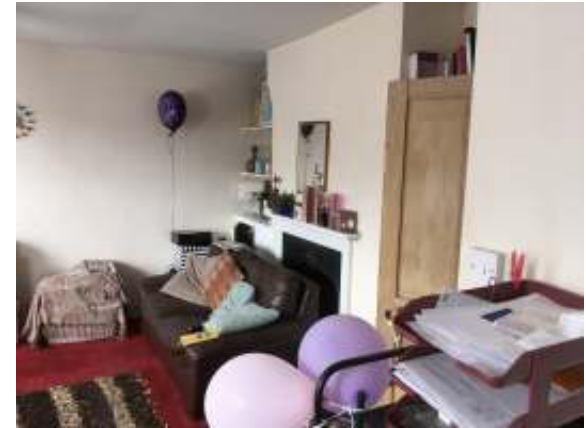
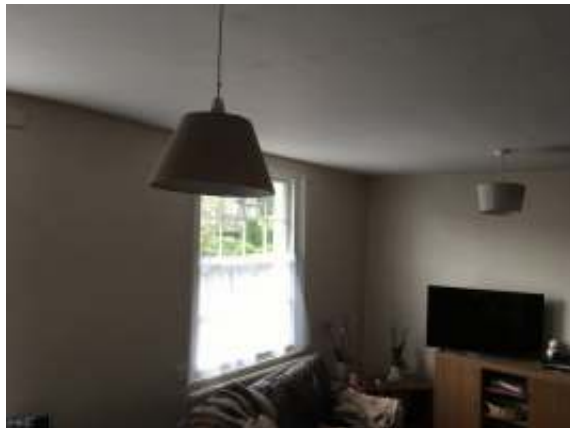
2.18	First floor private flat - front left reception room.		Photographs [63-65]					
2.18.1	Ceilings	Plasterboard ceiling with paint decoration.	Satisfactory Condition - note poor quality appearance generally.

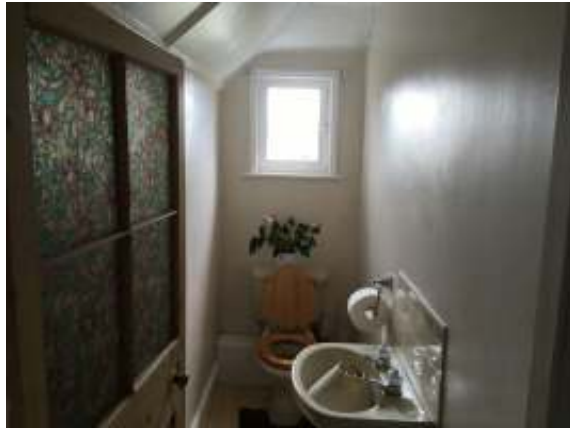
Photo 68

2.20	First floor private flat - WC		Photographs [68]					
2.20.1	Ceilings	Man made boarded ceiling with paint decoration.	Satisfactory Condition -					
2.20.2	Walls	Solid walls with plaster and paint decoration.	Satisfactory Condition - note isolated hollow plaster.
