CONDITION SURVEY
Punch Taverns
202954 | Liverpool Arms
79 Northgate Street
Chester

CONDITION SURVEY

25 June 2018

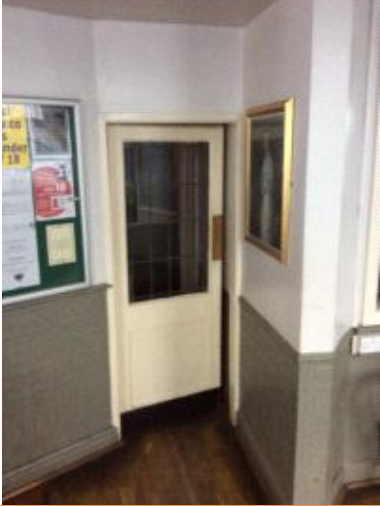
<p>Section: 02.04. TRADE AREA – BAR</p> <p>Element: 2.26. Internal Doors /</p> <p>Description: Timber door</p> <p>Grade: 2 - Satisfactory</p> <p>Priority: Years 1-5</p> <p>Action: Repair</p> <p>Defect:</p> <p>Scope of Works: Door won't closer properly</p> <p>Location: Bar area leading to ladies toilets</p>

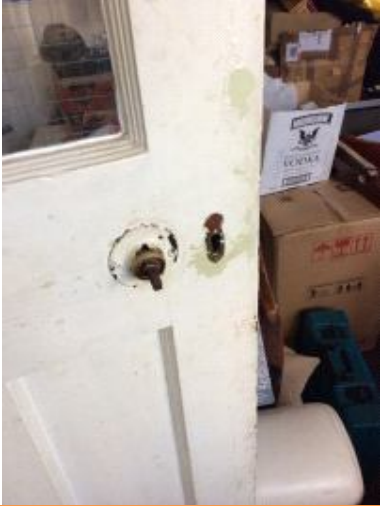
<p>Section: 03.01. DOMESTIC ACCOMMODATION - LOUNGE</p> <p>Element: 2.26. Internal Doors /</p> <p>Description: Timber door</p> <p>Grade: 1 - Poor</p> <p>Priority: Less than 1 year</p> <p>Action: Replace</p> <p>Defect:</p> <p>Scope of Works: Handles missing</p> <p>Location: Accommodation lounge</p>

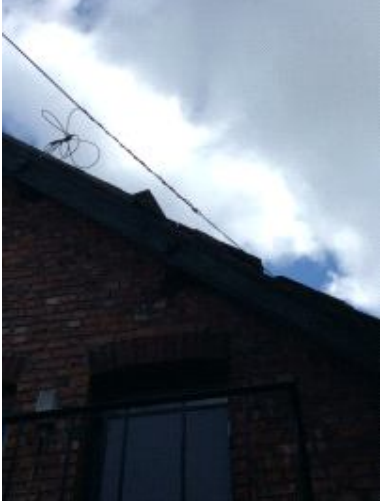
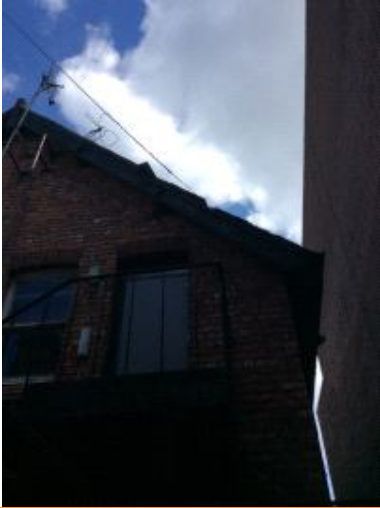
<p>Section: 01.01. PUB FRONTAGE</p> <p>Element: 2.6. Roof Coverings /</p> <p>Description: Natural slating</p> <p>Grade: 1 - Poor</p> <p>Priority: Less than 1 year</p> <p>Action: Repair</p> <p>Defect:</p> <p>Scope of Works: Loose slates</p> <p>Location: External</p>

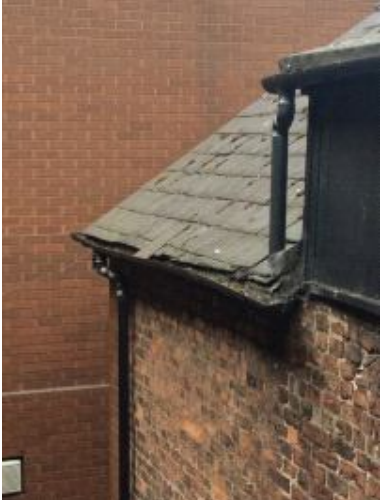
<p>Section: 01.01. PUB FRONTAGE</p> <p>Element: 2.6. Roof Coverings /</p> <p>Description: Natural slating</p> <p>Grade: 1 - Poor</p> <p>Priority: Less than 1 year</p> <p>Action: Repair</p> <p>Defect:</p> <p>Scope of Works: Loose slates</p> <p>Location: External</p>

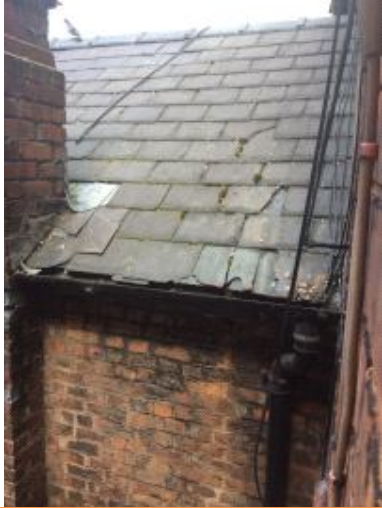
<p>Section: 01.01. PUB FRONTAGE</p> <p>Element: 2.6. Roof Coverings /</p> <p>Description: Natural slating</p> <p>Grade: 1 - Poor</p> <p>Priority: Less than 1 year</p> <p>Action: Repair</p> <p>Defect:</p> <p>Scope of Works: Loose slates</p> <p>Location: External</p>

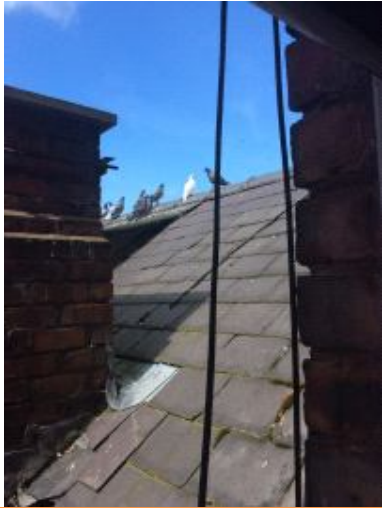
<p>Section: 01.01. PUB FRONTAGE</p> <p>Element: 2.6. Roof Coverings /</p> <p>Description: Natural slating</p> <p>Grade: 1 - Poor</p> <p>Priority: Less than 1 year</p> <p>Action: Repair</p> <p>Defect:</p> <p>Scope of Works: Loose slates</p> <p>Location: External</p>

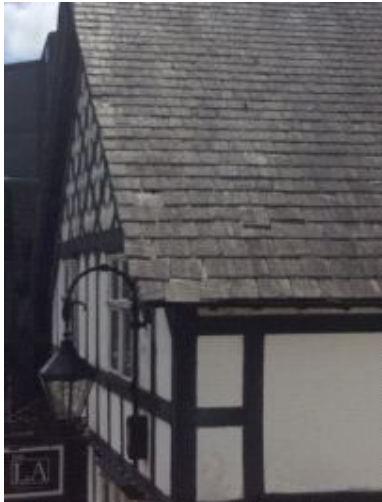
<p>Section: 01.01. PUB FRONTAGE</p> <p>Element: 2.6. Roof Coverings /</p> <p>Description: Natural slating</p> <p>Grade: 1 - Poor</p> <p>Priority: Less than 1 year</p> <p>Action: Repair</p> <p>Defect:</p> <p>Scope of Works: Loose slates</p> <p>Location: External</p>

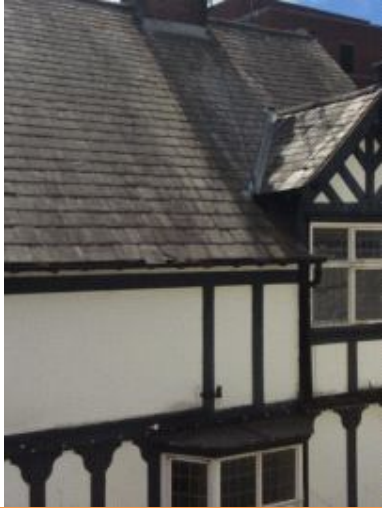
<p>Section: 01.01. PUB FRONTAGE</p> <p>Element: 2.6. Roof Coverings /</p> <p>Description: Natural slating</p> <p>Grade: 1 - Poor</p> <p>Priority: Less than 1 year</p> <p>Action: Repair</p> <p>Defect:</p> <p>Scope of Works: Loose slates</p> <p>Location: External</p>

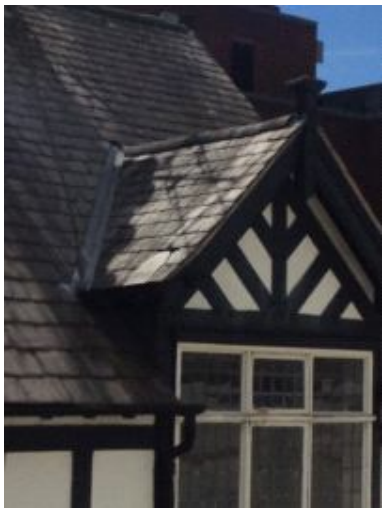
<p>Section: 01.01. PUB FRONTAGE</p> <p>Element: 2.6. Roof Coverings /</p> <p>Description: Natural slating</p> <p>Grade: 1 - Poor</p> <p>Priority: Less than 1 year</p> <p>Action: Repair</p> <p>Defect:</p> <p>Scope of Works: Loose slates</p> <p>Location: External</p>

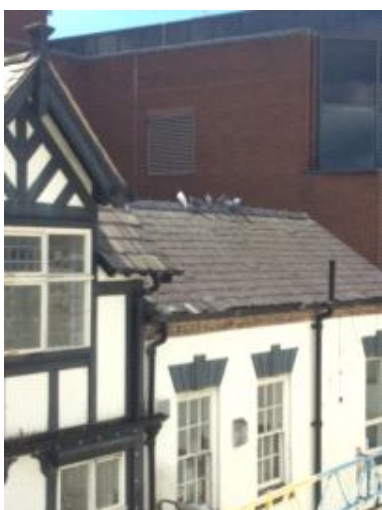
<p>Section: 01.01. PUB FRONTAGE</p> <p>Element: 2.6. Roof Coverings /</p> <p>Description: Natural slating</p> <p>Grade: 1 - Poor</p> <p>Priority: Less than 1 year</p> <p>Action: Repair</p> <p>Defect:</p> <p>Scope of Works: Loose slates</p> <p>Location: External</p>

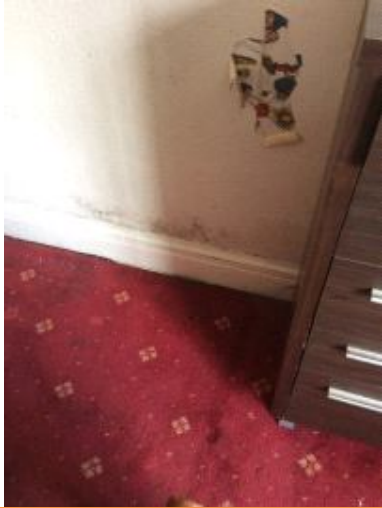
<p>Section: 03.03. DOMESTIC ACCOMMODATION - BEDROOM 1</p> <p>Element: 3.1. Wall Finishes /</p> <p>Description: Decoration generally</p> <p>Grade: 1 - Poor</p> <p>Priority: Less than 1 year</p> <p>Action: Repair</p> <p>Defect:</p> <p>Scope of Works: Damp issues</p> <p>Location: Accommodation bedroom 1</p>

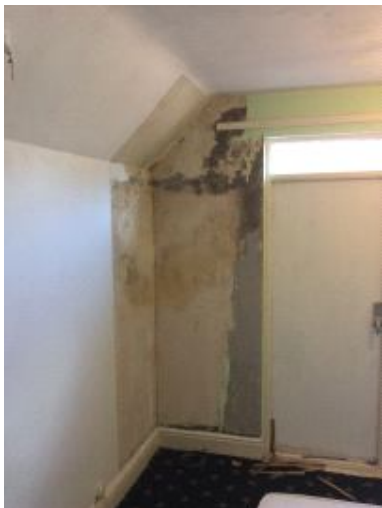
<p>Section: 03.04. DOMESTIC ACCOMMODATION - BEDROOM 2</p> <p>Element: 3.1. Wall Finishes /</p> <p>Description: Decoration generally</p> <p>Grade: 1 - Poor</p> <p>Priority: Less than 1 year</p> <p>Action: Repair</p> <p>Defect:</p> <p>Scope of Works: Damp damage caused by loose slates above on the roof</p> <p>Location: Accommodation bedroom 2</p>

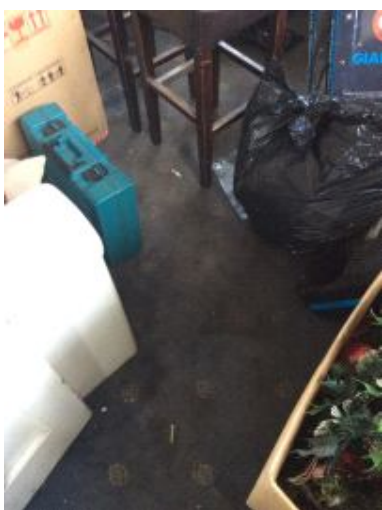
<p>Section: 03.01. DOMESTIC ACCOMMODATION - LOUNGE</p> <p>Element: 3.2. Floor Finishes /</p> <p>Description: Carpet</p> <p>Grade: 1 - Poor</p> <p>Priority: Less than 1 year</p> <p>Action: Replace</p> <p>Defect:</p> <p>Scope of Works: Poor condition</p> <p>Location: Accommodation lounge</p>

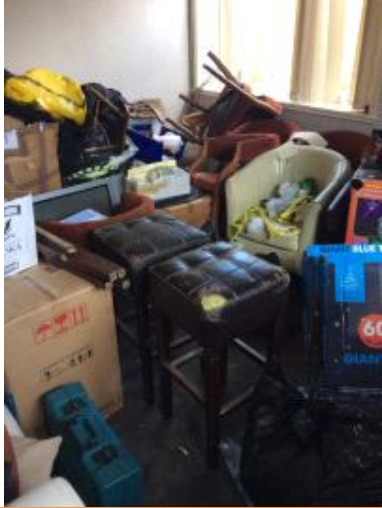
<p>Section: 03.01. DOMESTIC ACCOMMODATION - LOUNGE</p> <p>Element: 3.2. Floor Finishes /</p> <p>Description: Carpet</p> <p>Grade: 1 - Poor</p> <p>Priority: Less than 1 year</p> <p>Action: Replace</p> <p>Defect:</p> <p>Scope of Works: Poor condition</p> <p>Location: Accommodation lounge</p>

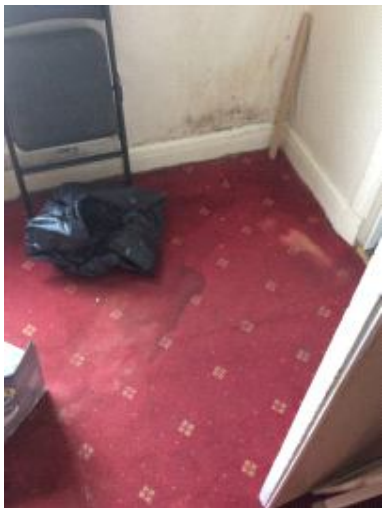
<p>Section: 03.03. DOMESTIC ACCOMMODATION - BEDROOM 1</p> <p>Element: 3.2. Floor Finishes /</p> <p>Description: Carpet</p> <p>Grade: 1 - Poor</p> <p>Priority: Less than 1 year</p> <p>Action: Replace</p> <p>Defect:</p> <p>Scope of Works: Poor condition</p> <p>Location: Accommodation bedroom 1</p>

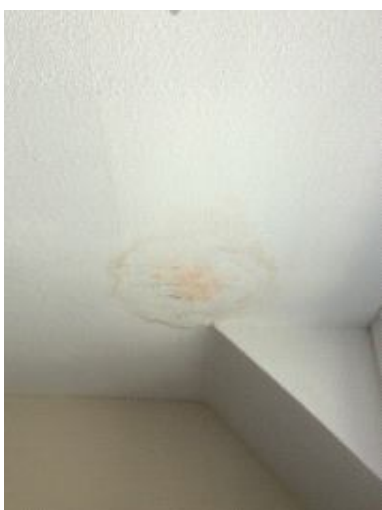
<p>Section: 03.05. DOMESTIC ACCOMMODATION - BEDROOM 3</p> <p>Element: 3.3. Ceiling Finishes /</p> <p>Description: Decoration paint</p> <p>Grade: 1 - Poor</p> <p>Priority: Less than 1 year</p> <p>Action: Repair</p> <p>Defect:</p> <p>Scope of Works: Damp damage from the loose slates on the roof above</p> <p>Location: Accommodation bedroom 3</p>

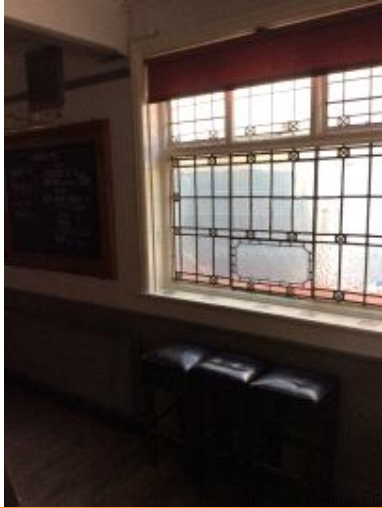
<p>Section: 02.04. TRADE AREA – BAR</p> <p>Element: 3.4. Internal Windows /</p> <p>Description: Glazing</p> <p>Grade: 1 - Poor</p> <p>Priority: Less than 1 year</p> <p>Action: Replace</p> <p>Defect:</p> <p>Scope of Works: Cracked glass</p> <p>Location: Trade area bar</p>

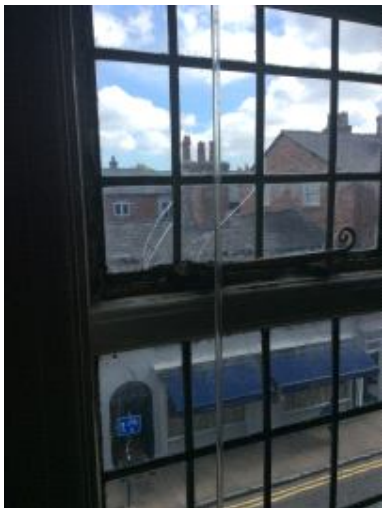
<p>Section: 03.03. DOMESTIC ACCOMMODATION - BEDROOM 1</p> <p>Element: 3.4. Internal Windows /</p> <p>Description: Glazing</p> <p>Grade: 1 - Poor</p> <p>Priority: Less than 1 year</p> <p>Action: Replace</p> <p>Defect:</p> <p>Scope of Works: Cracked glass</p> <p>Location: Accommodation bedroom 1</p>

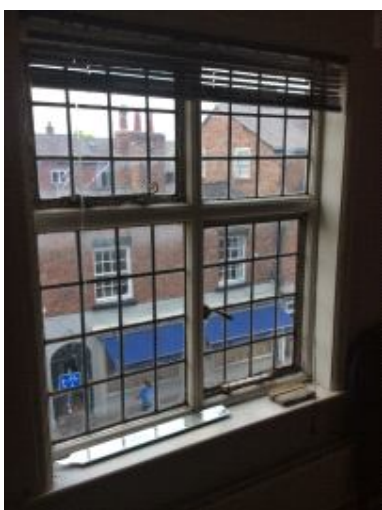
<p>Section: 03.03. DOMESTIC ACCOMMODATION - BEDROOM 1</p> <p>Element: 3.4. Internal Windows /</p> <p>Description: Glazing</p> <p>Grade: 1 - Poor</p> <p>Priority: Less than 1 year</p> <p>Action: Replace</p> <p>Defect:</p> <p>Scope of Works: Cracked glass</p> <p>Location: Accommodation bedroom 1</p>
