# Schedule of Condition

The Engine Inn  
Cripples Ease  
Nanclatra  
TR20 8NF

6th November 2018

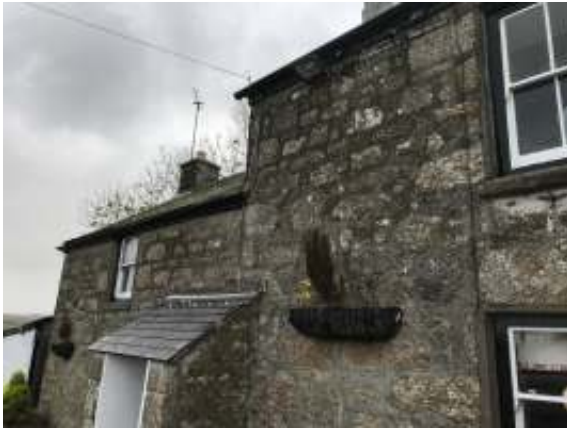
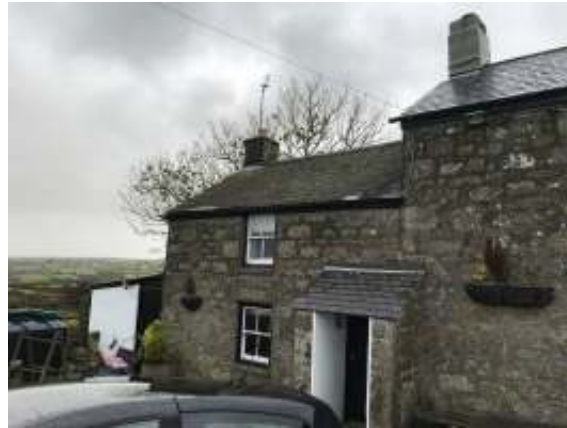
1.1	Front elevation		Photographs [ 2-3 ]					
1.1.1	Chimney	Two stone built chimneys, the right hand of which has brickwork upper section and cement flaunching. Both have clay pots and lead flashing. There is also a central chimney which has been rendered and appears to have a steel cowling.	Satisfactory Condition

1.1.2	Rainwater Goods	Painted plastic gutters, plastic downpipes with surface water gullies.	Satisfactory Condition					
1.1.3	Roof	Multiple pitched roofs with both natural and artificial slate covering and concrete ridge tiles.	Satisfactory Condition - note moss growth, replaced tiles and missing tile from left section of roof.

1.1.4	Walls	Rubble filled stonewall with stone facing.	Satisfactory Condition - note some vegetation to wall.					
1.1.5	Joinery	Three solid timber entrance doors, fascia board and multiple timber framed sash windows all paint finished.	Satisfactory Condition

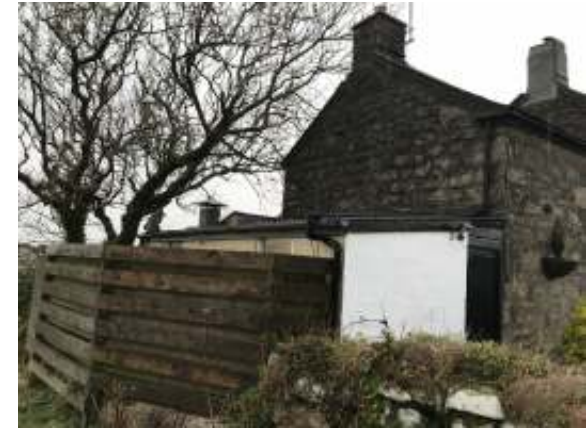
Photo 4

1.2	<b>Left elevation</b>		<b>Photographs [ 4 ]</b>					
1.2.1	Rainwater Goods	Painted plastic gutters running from front elevation to downpipe running over single storey extension and into unseen surface water drainage. Also plastic gutter to flat roof and downpipe running into unseen drainage connection.	Satisfactory Condition where seen. Some vegetation to extension gutter.

1.2.2	Roof	Shallow flat roof covered with asbestos board.	Satisfactory Condition					
1.2.3	Walls	Rubble filled stonewall with stone facing. Solid masonry single storey extension with paint decoration.	Satisfactory Condition

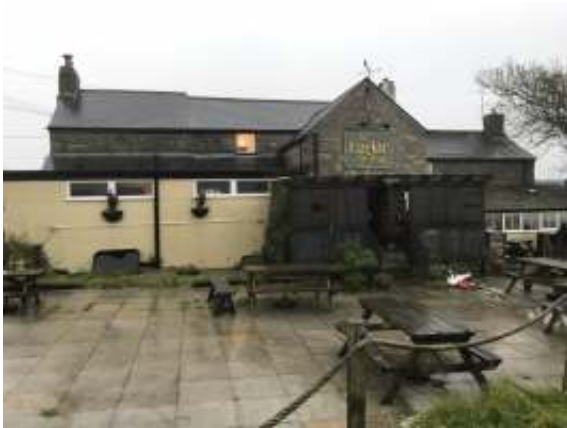
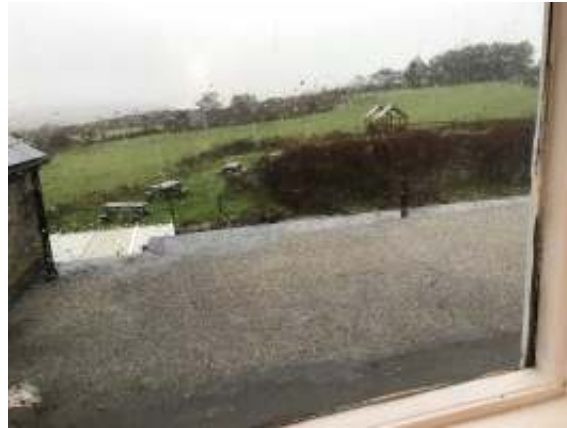
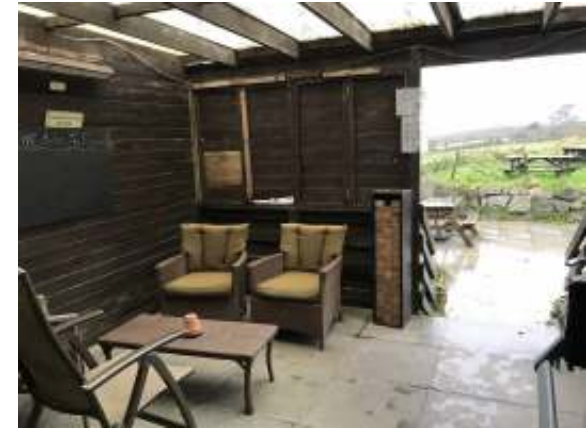
1.3.1	Rainwater Goods	Painted plastic gutters and downpipes with surface water gullies.	Satisfactory Condition - note some downpipes miss gullies.

1.3.2	Roof	Multiple pitched roofs with both natural and artificial slate covering, concrete ridge tiles and lead valley gutter. Also mineral felt flat roof to left-hand side, plastic covering to lean-to and asbestos board to right-hand side single-storey extensions.	Satisfactory Condition overall but note some debris and moss to right side roofs.

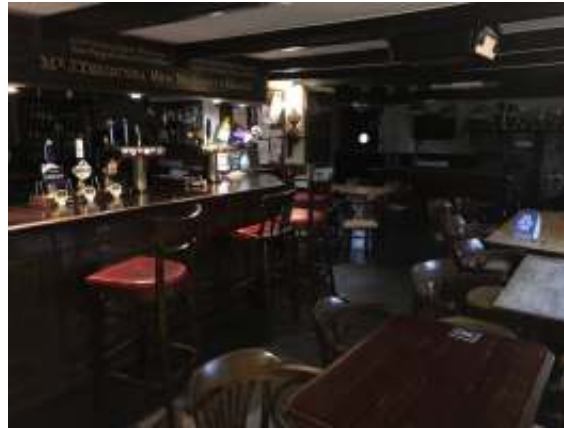
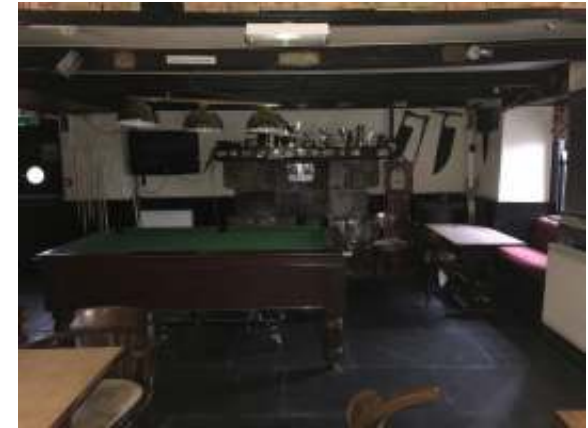
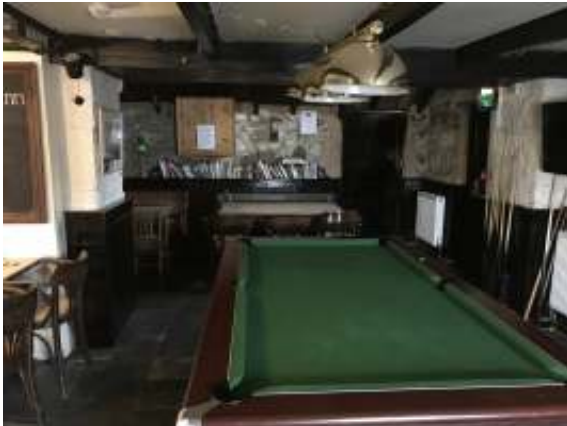
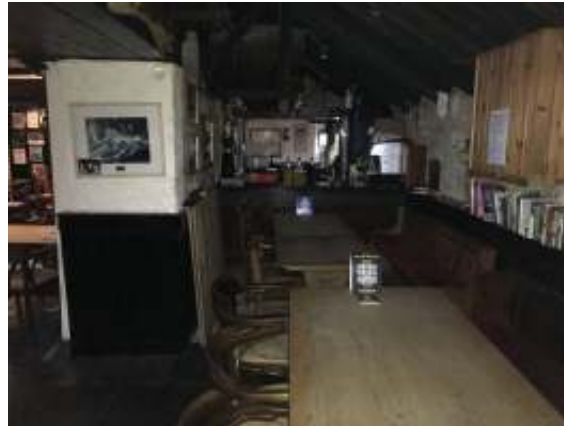
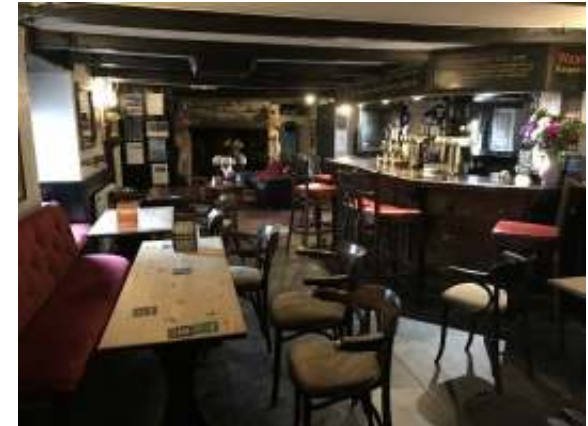
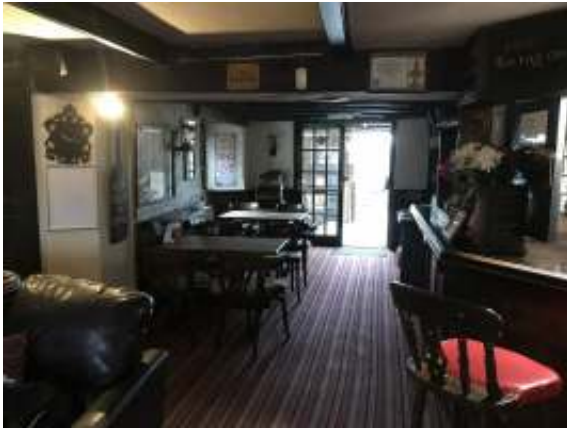
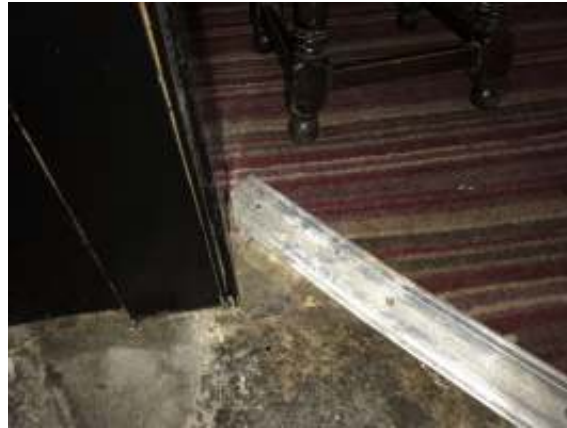
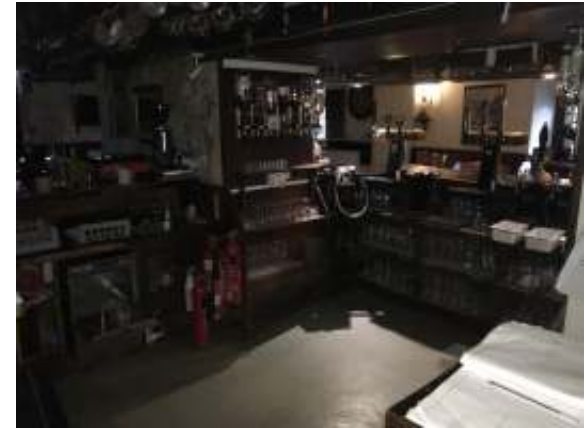
2.6.3	Floors	Solid concrete floor, stone flooring and carpet finishes. There is vinyl fitted to the rear of the bar.	Satisfactory Condition - note metal strip to edge of carpet loose.

2.6.4	Joinery	Timber bar area with mixed shelving. Fixed timber seating areas, exposed framework and mixed shelving throughout, all paint finished.	Satisfactory Condition - note some wear and tear to bar counter.

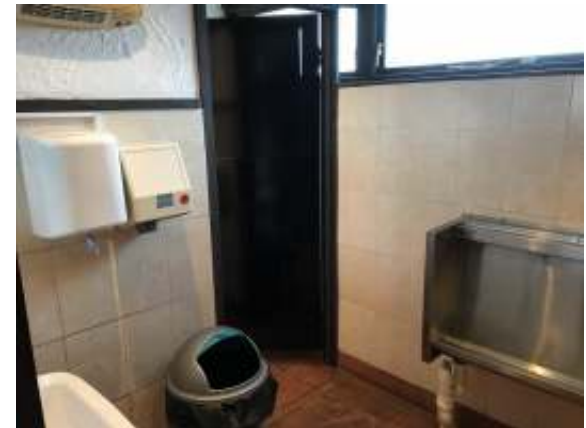
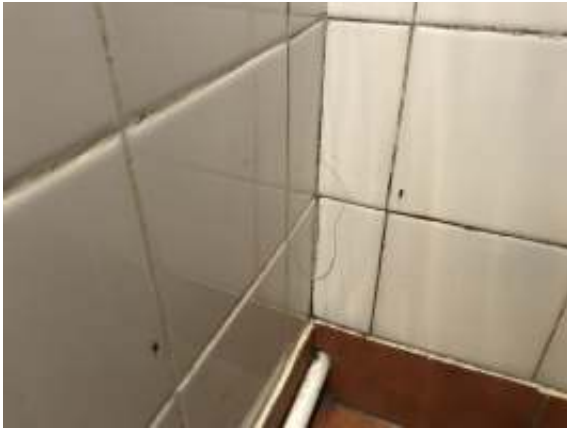
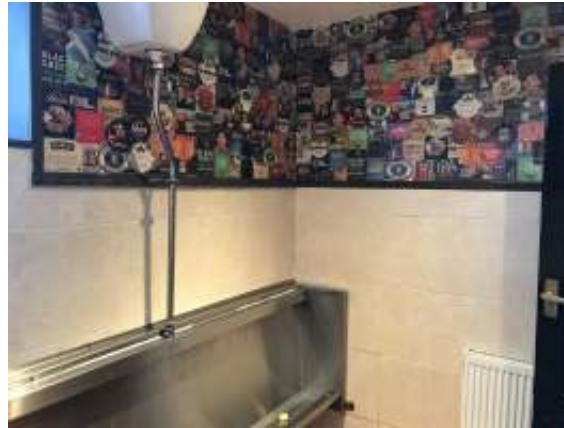
2.8.1	Ceilings	Plasterboard ceiling with textured paint decoration.	Satisfactory Condition					
2.8.2	Walls	Mixed timber stud partitions and masonry walls with ceramic tiling and textured paint decoration.	Satisfactory Condition - note some removal holes to tiles and one cracked at low level rear of toilet door.

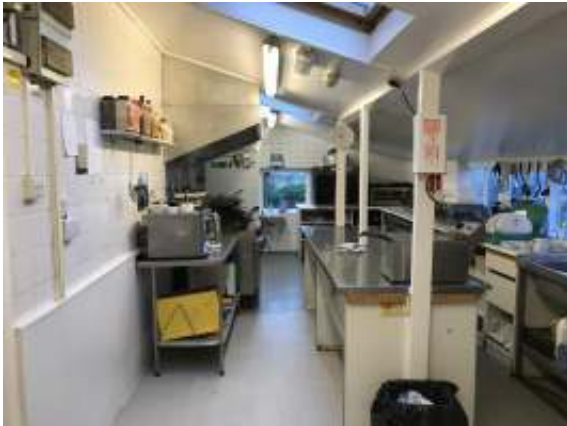
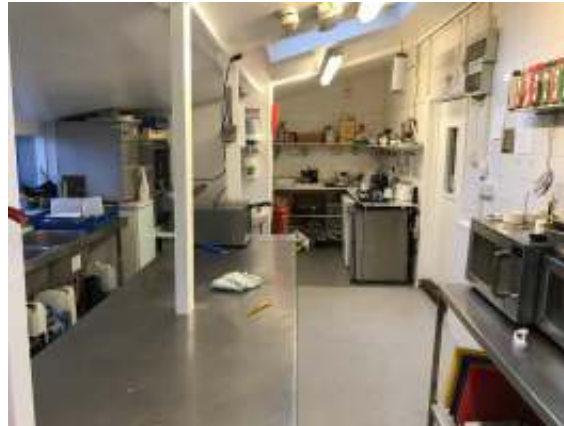
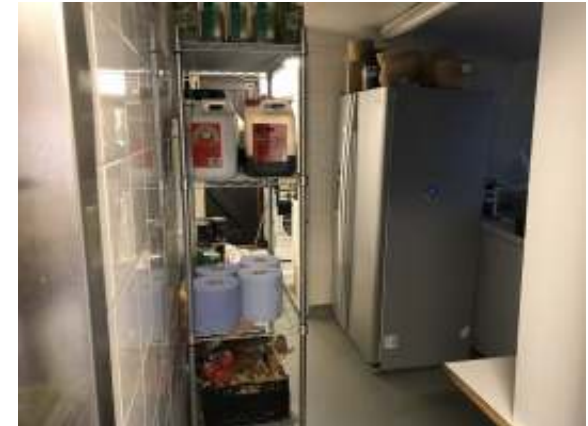
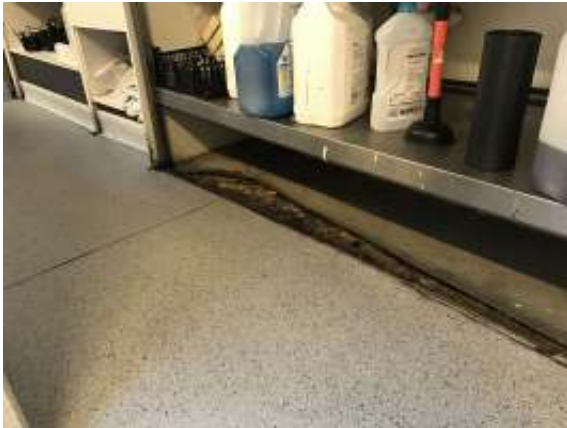
2.10.1	Ceilings	Plasterboard ceiling with paint decoration.	Satisfactory Condition					
2.10.2	Walls	Mixed timber stud partitions and masonry walls with plastic cladding and ceramic tiling.	Satisfactory Condition - note some wear and tear to tiles including removal holes and hairline cracks.

2.10.3	Floors	Solid concrete floor with vinyl covering.	Satisfactory Condition - note individual areas of damaged vinyl under sink.					
2.10.4	Joinery	Glazed timber doors, solid timber door to front entrance, timber framed windows and roof windows, working surfaces, mixed storage and shelving.	Satisfactory Condition

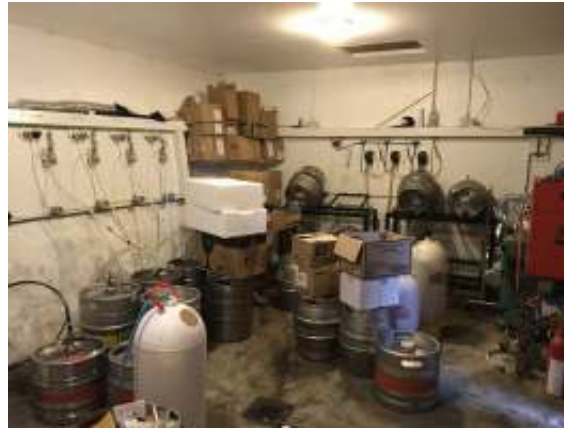
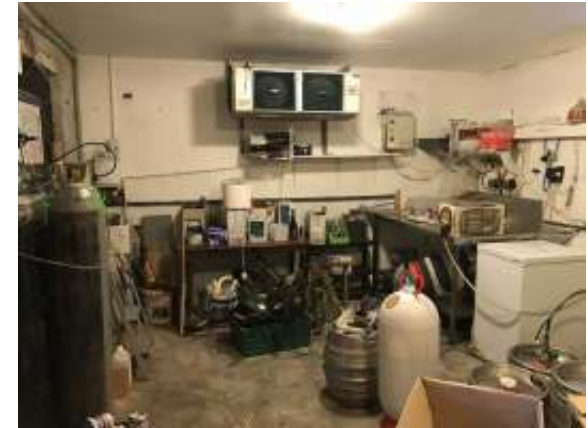
2.11.1	Ceilings	Plasterboard ceiling with paint decoration.	Satisfactory Condition					
2.11.2	Walls	Solid masonry walls and partitions with paint decoration.	Satisfactory Condition - lightly soiled due to wear and tear- painting in progress.

2.11.3	Floors	Solid concrete floor and no floor coverings.	Satisfactory Condition - soiled in places due to wear and tear.					
2.11.4	Joinery	Solid timber door, boarded windows, loft hatch and mixed shelving, all paint finished.	Satisfactory Condition

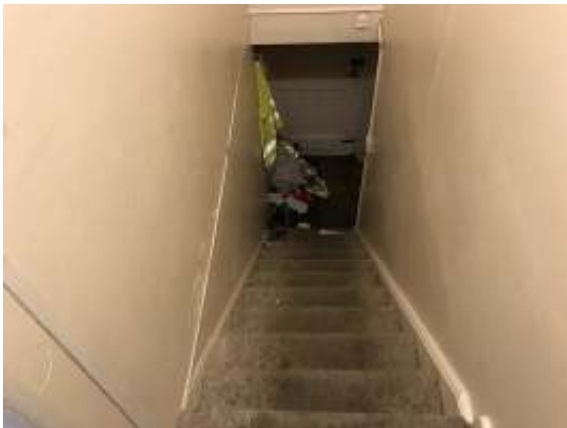
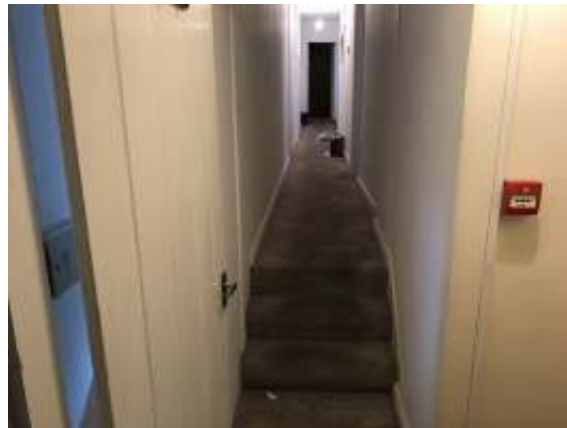
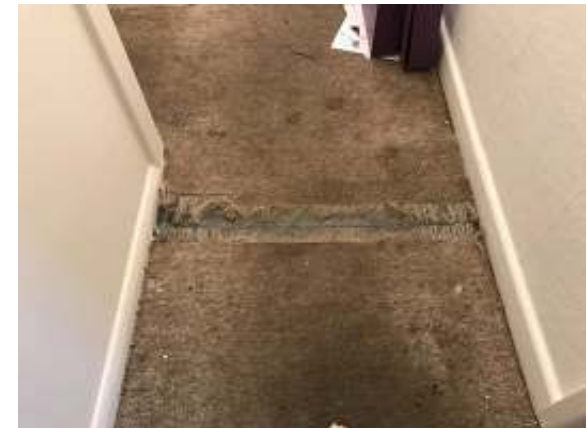
2.16.3	Floors	Suspended timber floor with carpet finishes.	Poor Condition - carpet worn and fraying at joints.					
2.16.4	Joinery	Timber staircase with stringer but no handrail. Solid timber doors, skirting boards, loft hatch and timber framed windows.	Satisfactory Condition

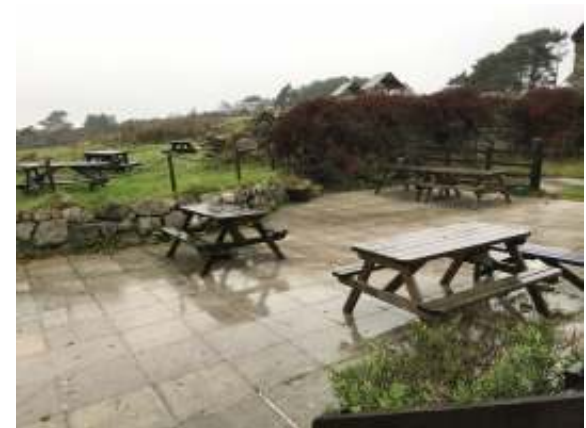
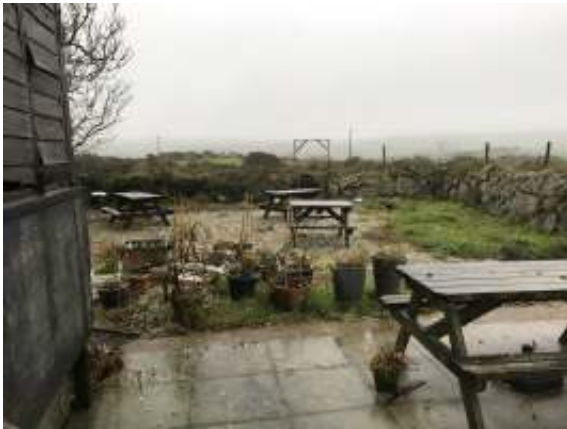
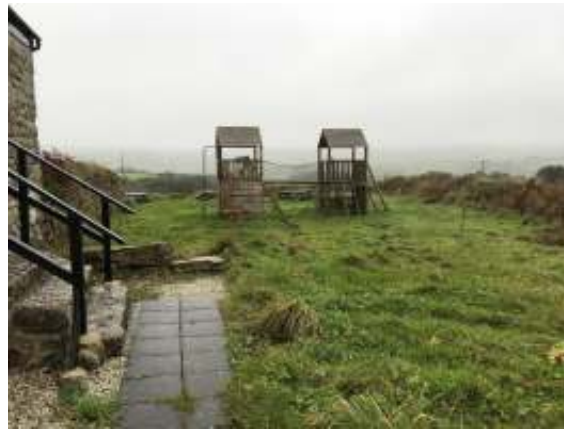
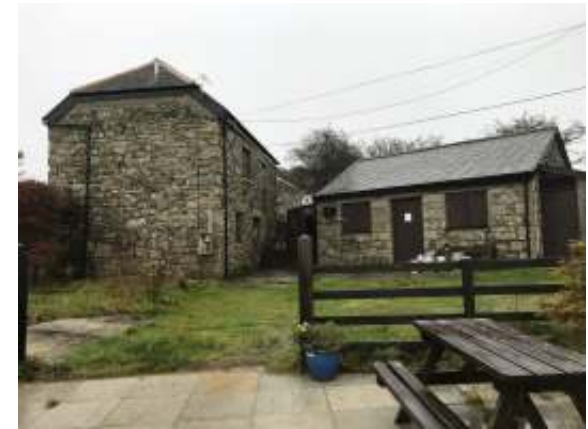
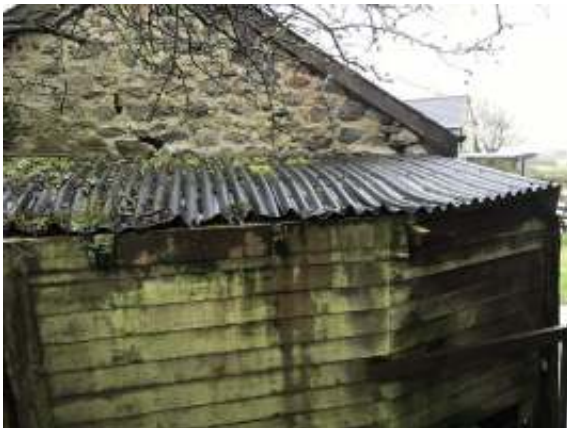
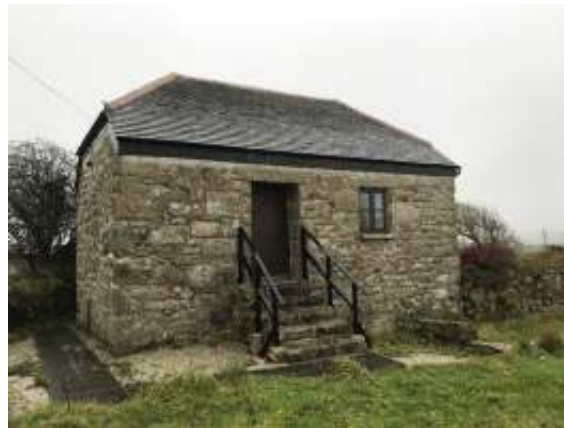
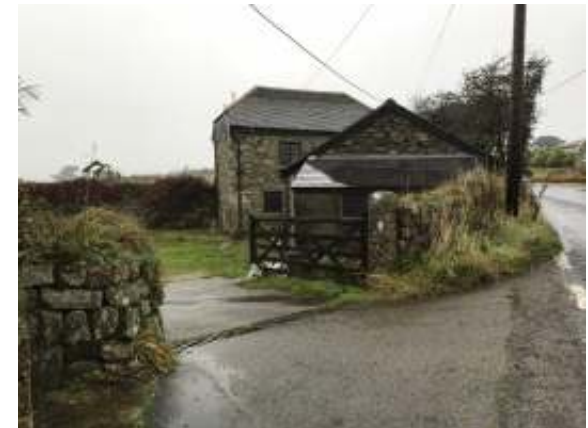
1.5.1	Grounds	Partial concrete slab hardstanding enclosed by rubble stone walls and timber fencing. Large grassy garden area enclosed by mixed boundary fencing. Timber play structure to garden and mixed planting throughout.	Satisfactory Condition - garden maintenance required.
