Schedule of Condition

Property Address:	Jolly Colliers 57 West Street Bristol BS3 3NU	
Outlet Number:	300050	
Document Reference:	N/A	Rev. Year 0
Document Date:	29th November 2018

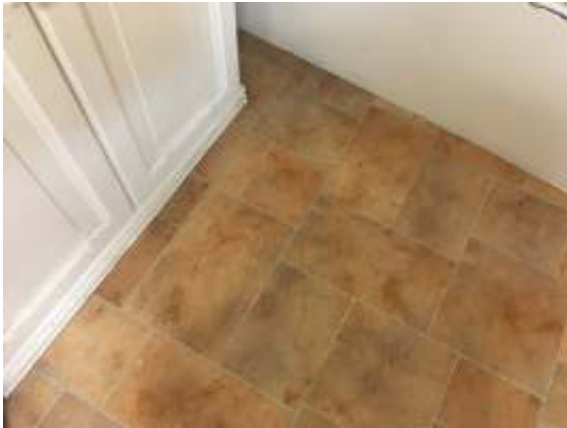
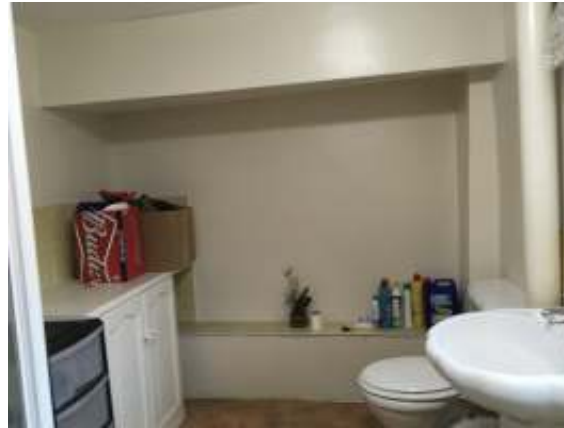
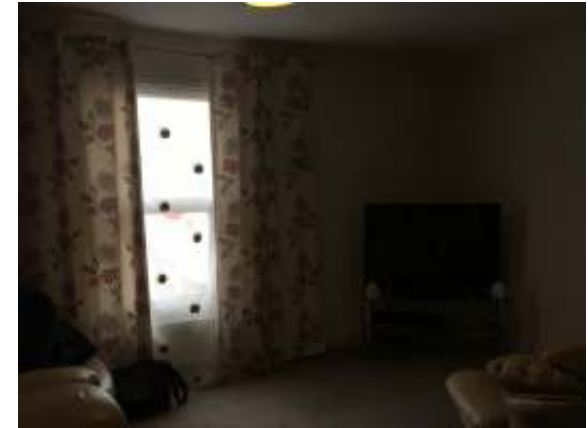
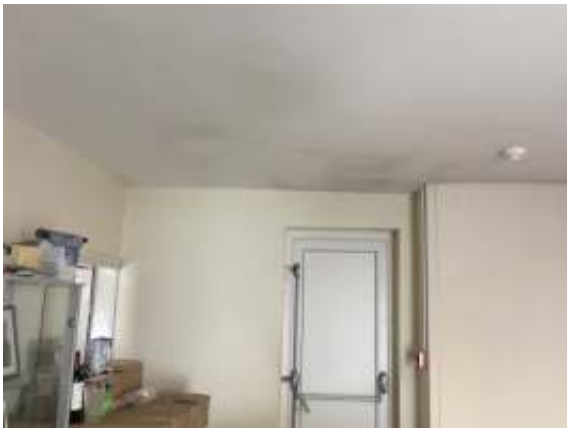
1.1	First Floor Bathroom		Photographs [2-5]					
1.1.1	Ceilings	Plasterboard ceiling with painted decoration.	Satisfactory Condition					
1.1.2	Walls	Solid masonry walls and partitions with, plaster finishes, ceramic tiles and paint decoration.	Satisfactory Condition - grout discoloured behind toilet and sink

1.1.3	Floors	Suspended timber floor with vinyl floor coverings.	Poor Condition - vinyl worn with some tears.					
1.1.4	Joinery	Double glazed UPVC windows, timber panel door, skirting boards and architraves with painted decoration.	Satisfactory Condition

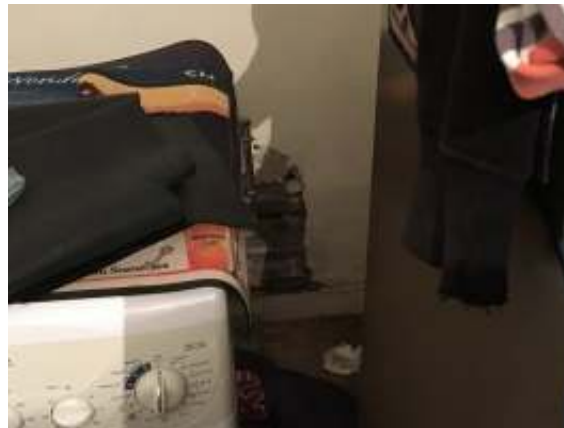
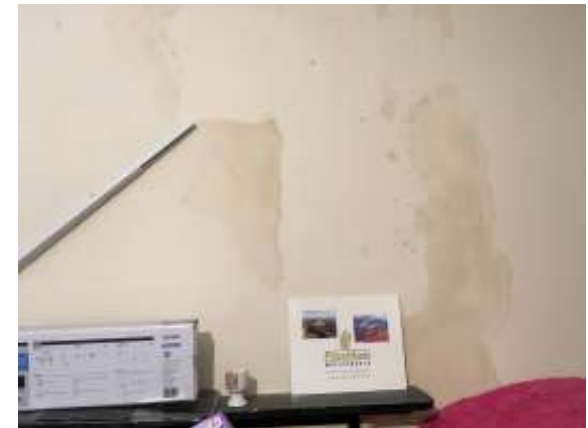
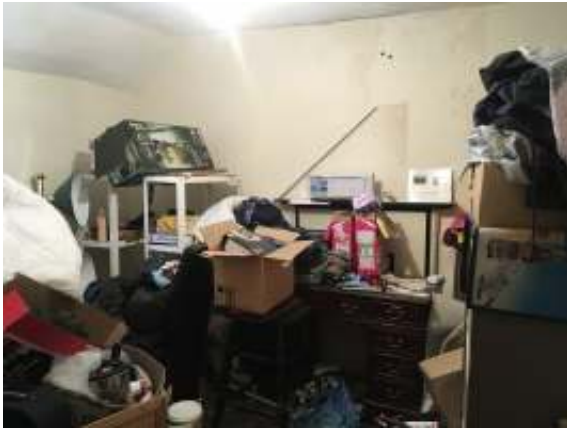
1.2	First Floor Office/Store		Photographs [6-8]					
1.2.1	Ceilings	Plasterboard ceiling with painted decoration.	Satisfactory Condition - some areas discoloured/damp patches

1.2.2	Walls	Solid masonry walls and partitions with, plaster finishes, lining paper and paint decoration.	Poor Condition - hole in plaster with pipe work protruding. Areas where plaster has been repaired and some staining/discolouration.

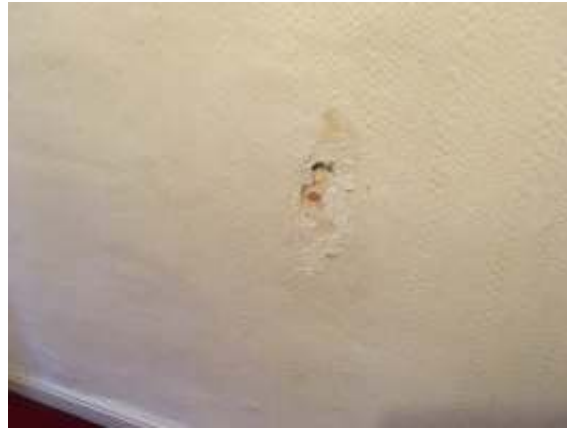
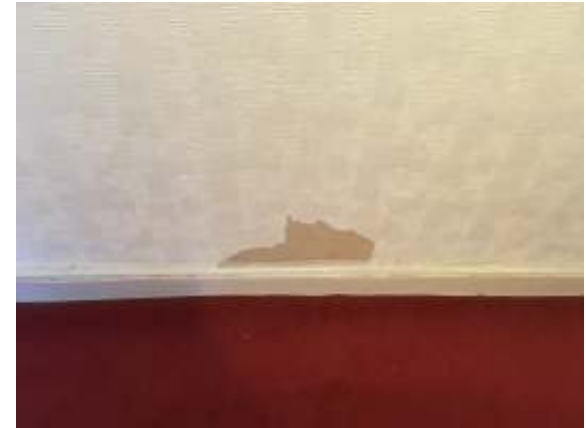
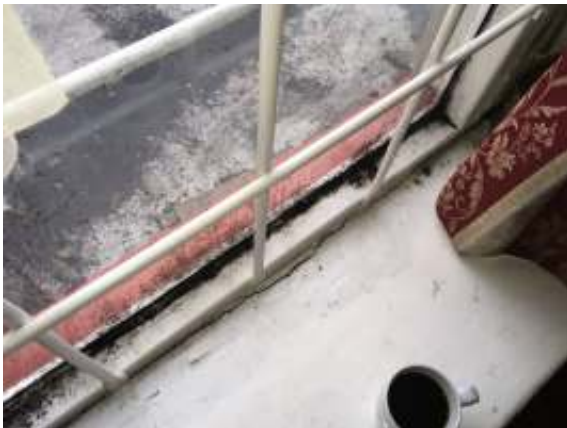
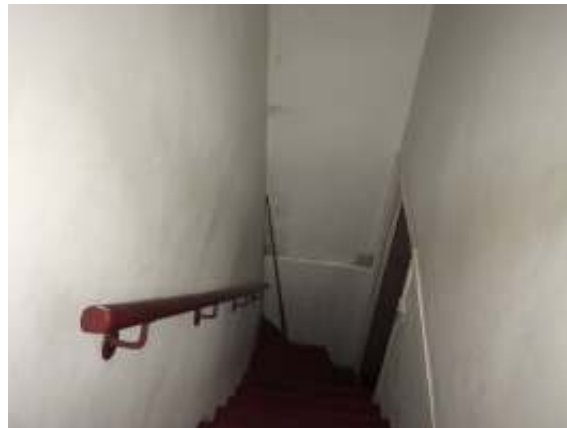
1.3	First Floor Corridor & Stairs.		Photographs [9-12]					
1.3.1	Ceilings	Plasterboard ceiling with painted decoration.	Satisfactory Condition - some evidence of damp to the corner of the stairwell.

1.3.2	Walls	Solid masonry walls and partitions with, plaster finishes, lining paper and paint decoration.	Satisfactory Condition - some localised damage to plaster/lining paper. Staining from damp to corner of stairwell.

1.3.3	Floors	Suspended timber floor with carpet floor coverings.	Satisfactory Condition - some unevenness to the floorboards in areas.					
1.3.4	Joinery	Single glazed timber windows, timber panel door, skirting boards and architraves with painted decoration.	Satisfactory Condition - deterioration to paintwork on window frames.

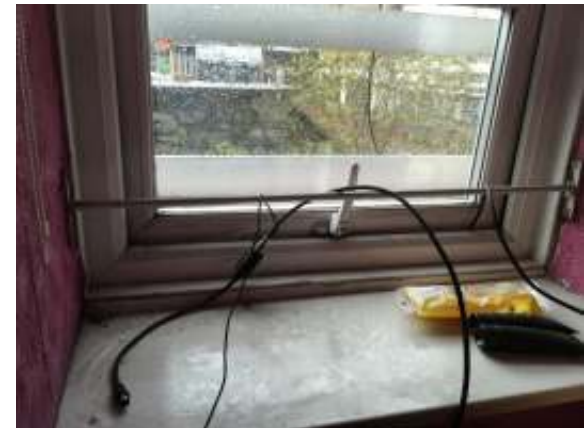
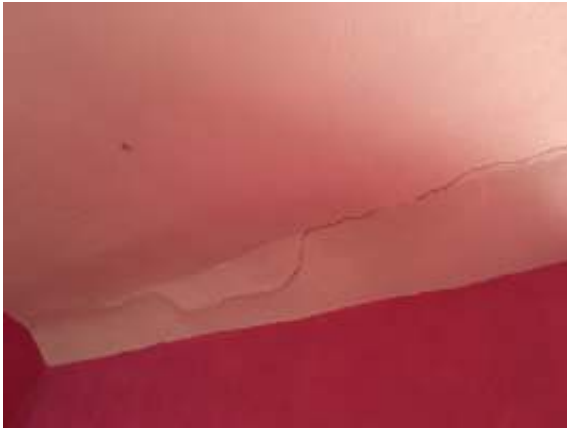
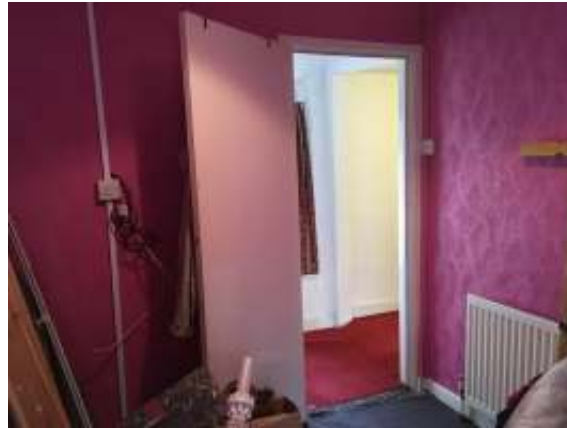
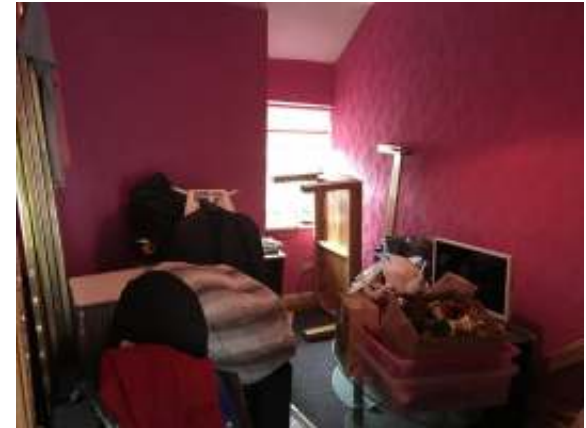
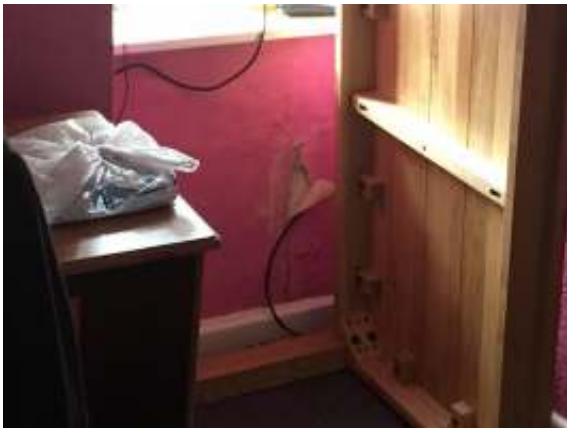
1.4	Spare Bedroom		Photographs [13-17]					
1.4.1	Ceilings	Plasterboard ceiling with artex finish and painted decoration.	Satisfactory Condition - cracking along one side.

1.4.2	Walls	Solid masonry walls and partitions with, plaster finishes, lining paper and paint decoration.	Satisfactory Condition - lining paper torn under window.

1.4.3	Floors	Suspended timber floor with carpet floor coverings.	Satisfactory Condition -not secured in doorway.					
1.4.4	Joinery	Timber panel door, skirting boards and architraves with painted decoration. Double glazed UPVC window.	Satisfactory Condition

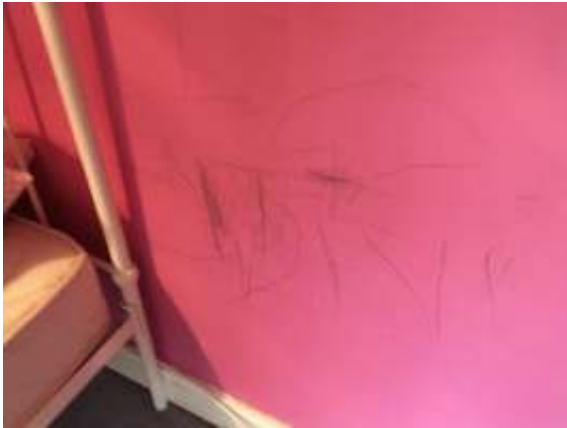
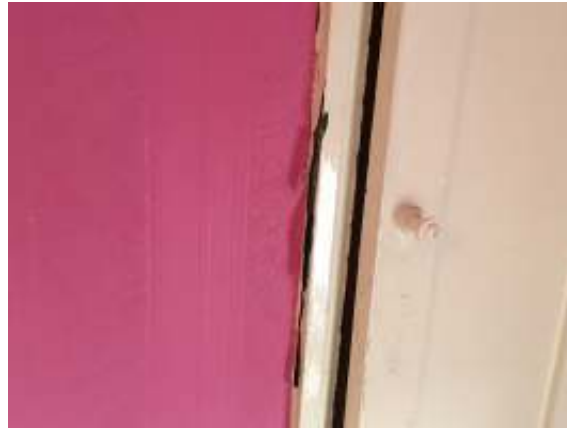
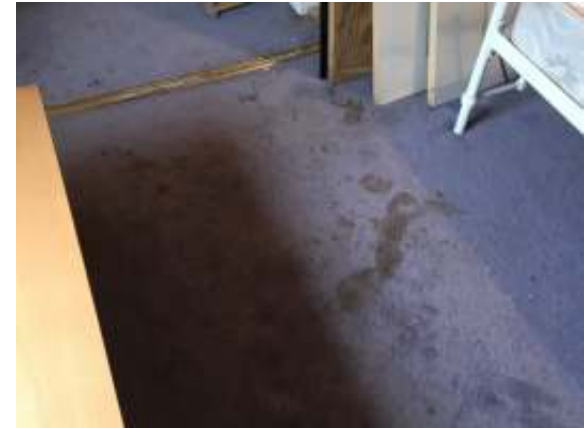
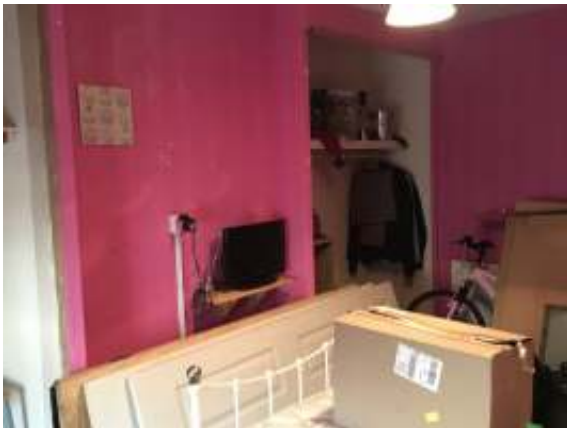
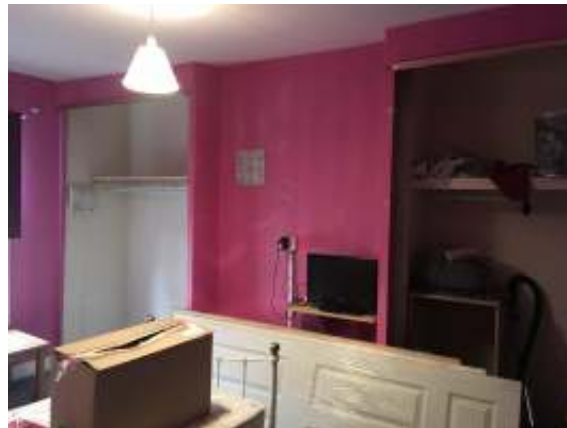
1.6	Second Bedroom		Photographs [20-24]					
1.6.1	Ceilings	Plasterboard ceiling with painted decoration.	Satisfactory Condition					
1.6.2	Walls	Solid masonry walls and partitions with, plaster finishes, lining paper and paint decoration.	Poor Condition - holes in walls from previous fixtures and walls have been drawn over.

1.6.3	Floors	Suspended timber floor with floor coverings.	Poor Condition - carpet heavily stained.					
1.6.4	Joinery	Double glazed plastic windows. Timber panel door, skirting boards and architraves with painted decoration.	Satisfactory Condition - doors to fitted cupboards missing, architrave split.

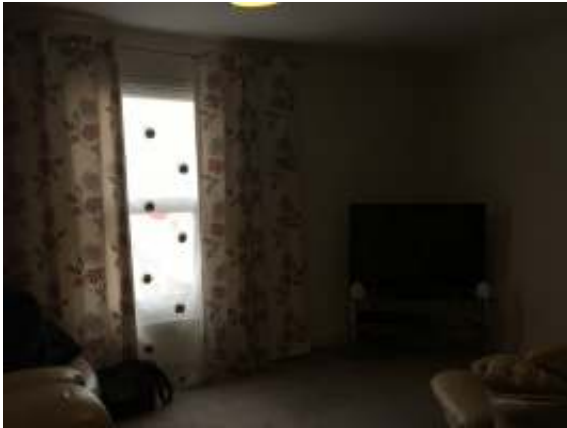
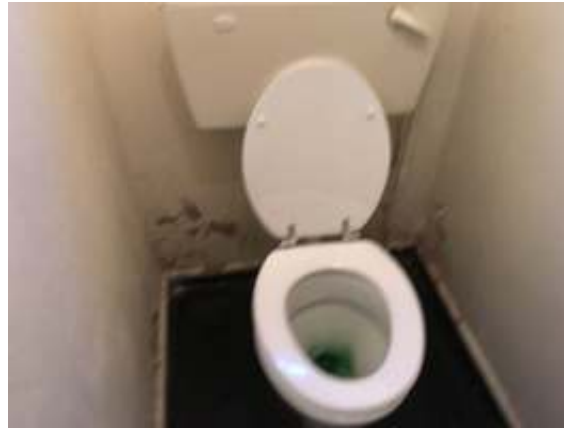
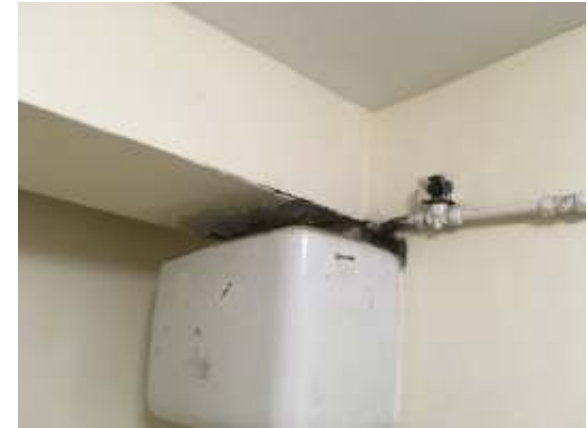
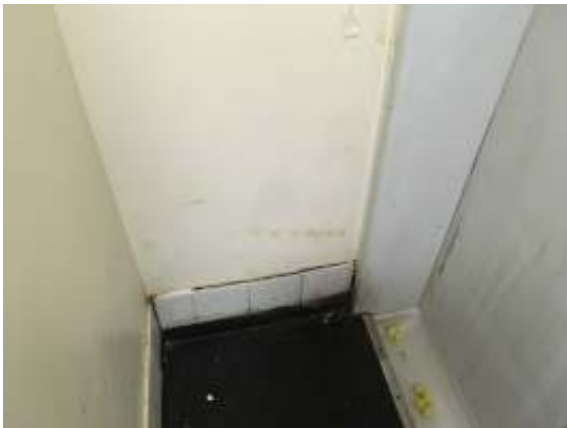
1.8	Gents Toilets		Photographs [27-30]					
1.8.1	Ceilings	Plasterboard ceiling with painted decoration.	Satisfactory Condition					
1.8.2	Walls	Solid masonry walls and partitions with, plaster finishes, lining paper and paint decoration.	Poor Condition -plaster damaged due to moisture ingress to low level especially along the external walls.

1.8.3	Floors	Solid concrete floor with vinyl floor coverings.	Poor Condition - vinyl loose due to moisture ingress.

1.8.4	Joinery	Single glazed timber windows, timber panel door, skirting boards and architraves with painted decoration.	Poor Condition - decoration worn and skirtings have moisture ingress.

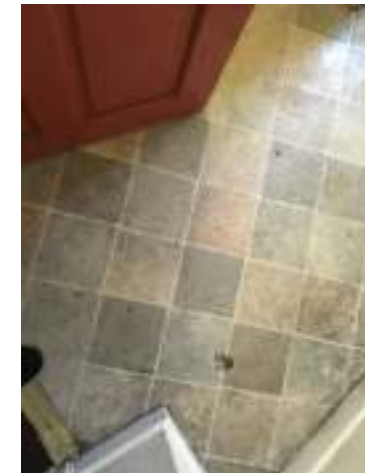
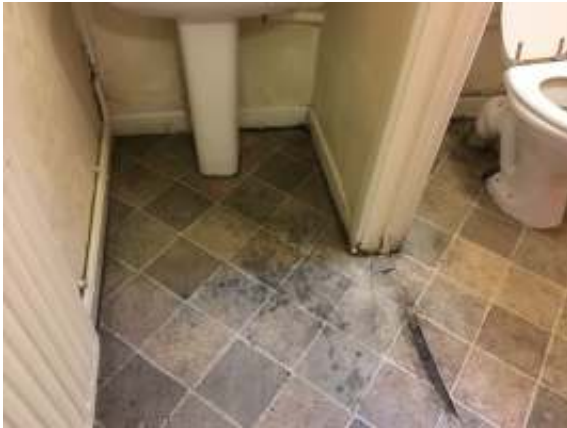
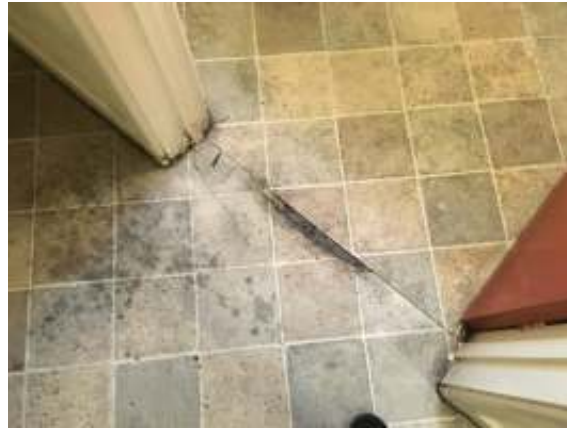
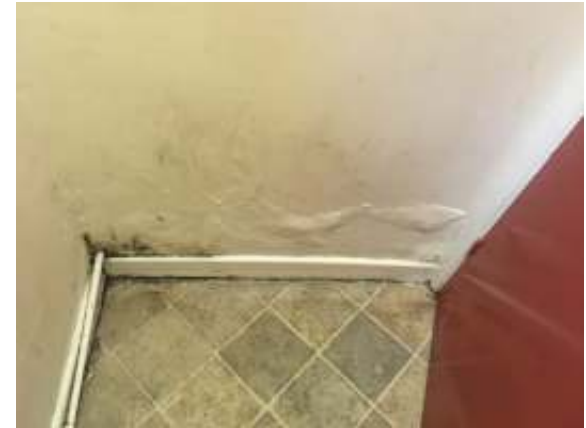
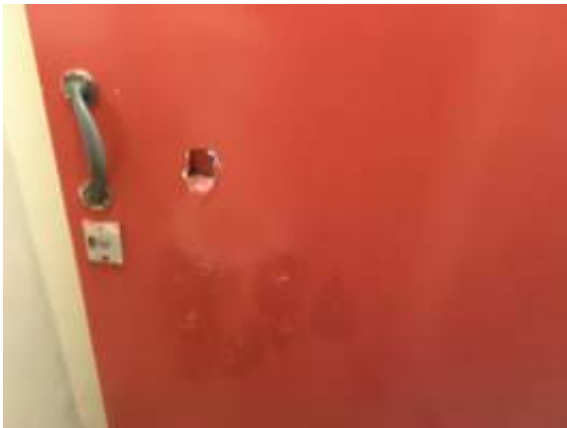
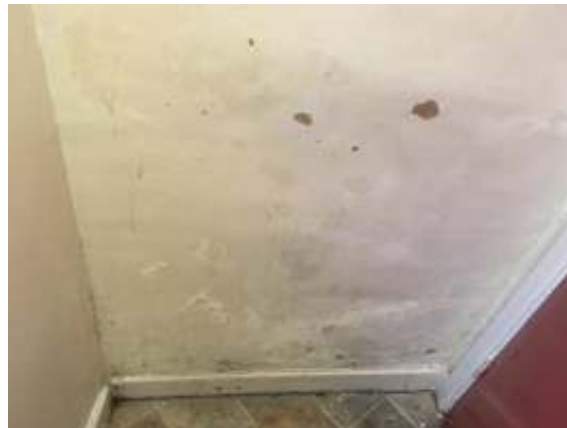
1.9	Ladies Toilets		Photographs [31-36]					
1.9.1	Ceilings	Plasterboard ceiling with painted decoration.	Satisfactory Condition					
1.9.2	Walls	Solid masonry walls and partitions with, plaster finishes, ceramic tiles and paint decoration.	Poor Condition - plaster damaged due to moisture ingress to low level especially along the external walls.

1.9.3	Floors	Solid concrete floor with vinyl floor coverings.	Poor Condition - vinyl torn and has holes in several places and has lifted due to moisture ingress which has caused mould staining in places.

1.9.4	Joinery	Single glazed timber windows, timber panel door, skirting boards and architraves with painted decoration.	Poor Condition - hole in door, skirtings have moisture ingress and window frame in poor condition.

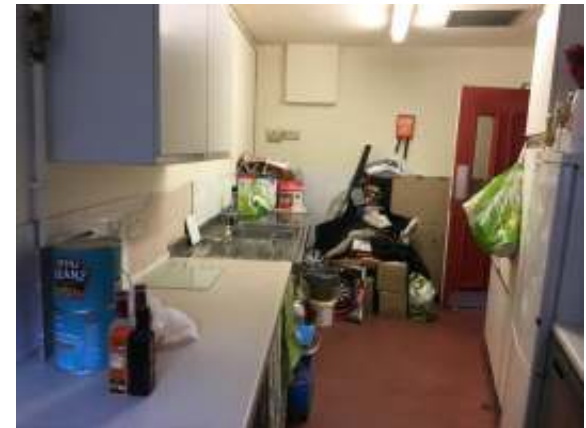
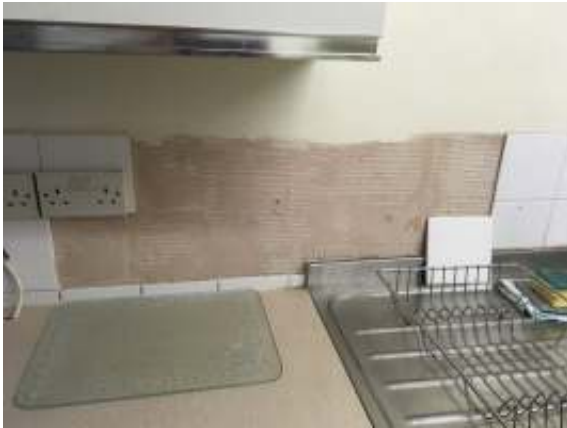
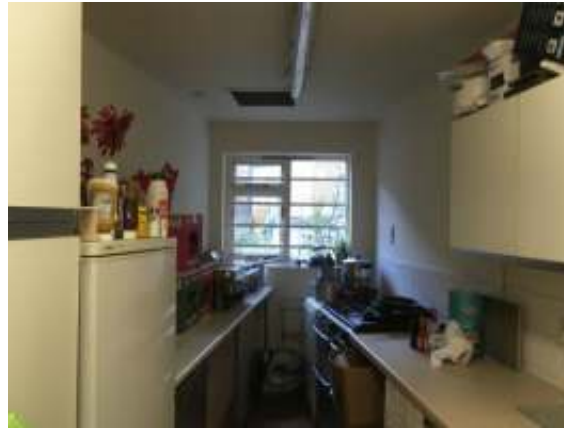
1.10	Kitchen GF		Photographs [37-39]					
1.10.1	Ceilings	Plasterboard ceiling with painted decoration.	Satisfactory Condition					
1.10.2	Walls	Solid masonry walls and partitions with, plaster finishes, lining paper and paint decoration.	Satisfactory Condition - some tiles have fallen off around the sink area.

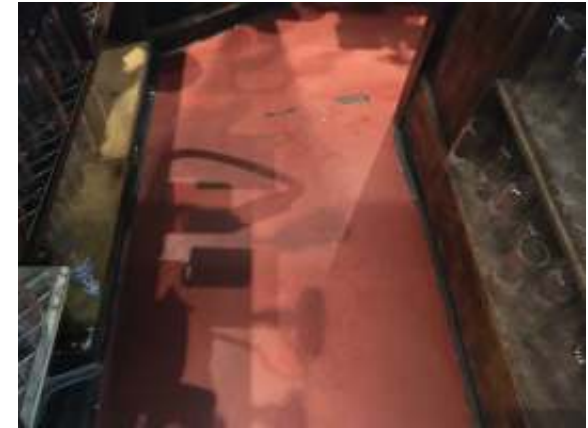
Photo 40

1.11.3	Floors	Mixed timber and concrete floor, timber boarding, vinyl flooring and carpet finishes.	Satisfactory Condition - vinyl has a hole in it and carpet generally worn.

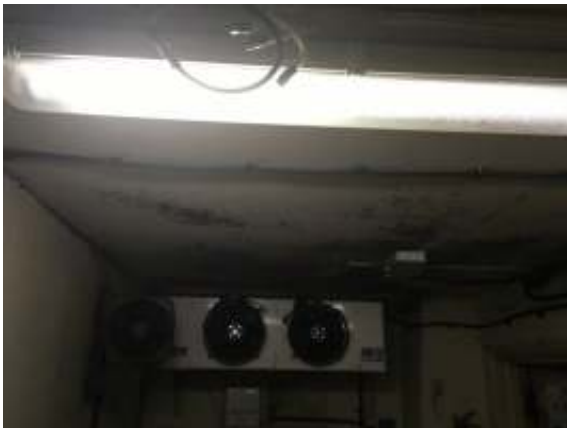
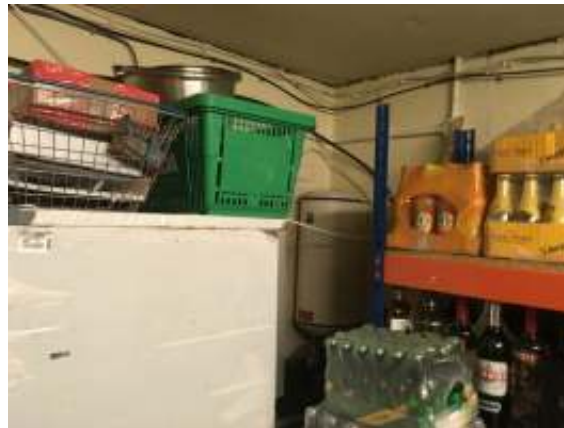
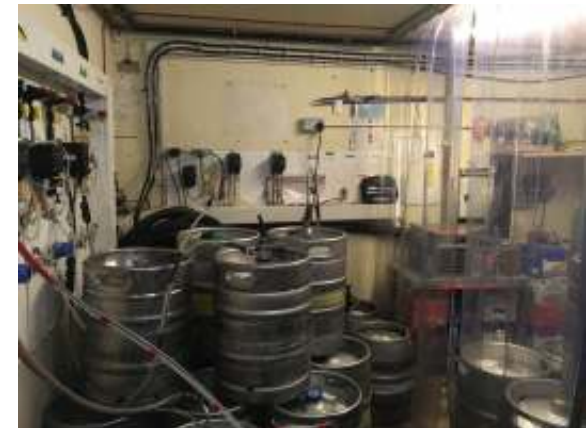
1.12	Beer Cellar GF		Photographs [41-43]					
1.12.1	Ceilings	Plasterboard ceiling with painted decoration.	Poor Condition - discoloured with a combination of damp and mould.

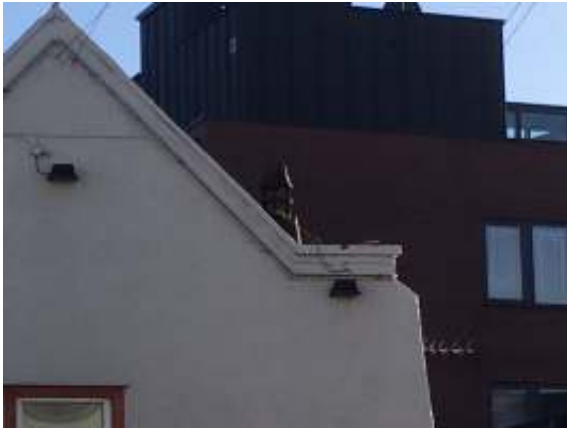
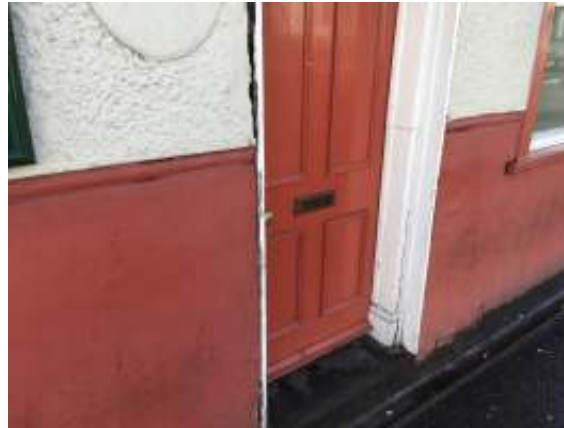
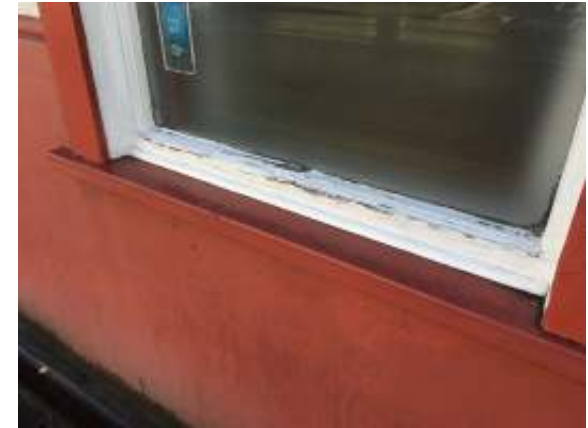
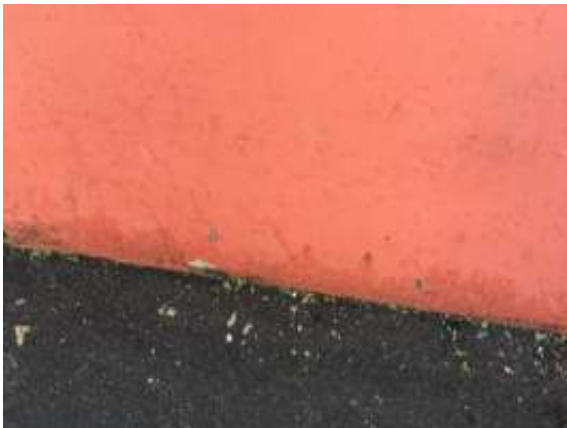
2.13.3	Roof	Multiple pitched roofs, one with clay tiles and one unseen. Flat roof with mineralised felt covering.	Satisfactory Condition					
2.13.4	Walls	Solid masonry wall with render finishes and painted decoration.	Poor Condition - render cracked, with some sections loose and eroded at low level allowing water penetration.

2.13.5	Joinery	Double glazed plastic framed windows to the first floor. Single glazed timber windows, timber panel door and timber gate with painted decoration	Satisfactory Condition - paint flaking to woodwork exposing timber.

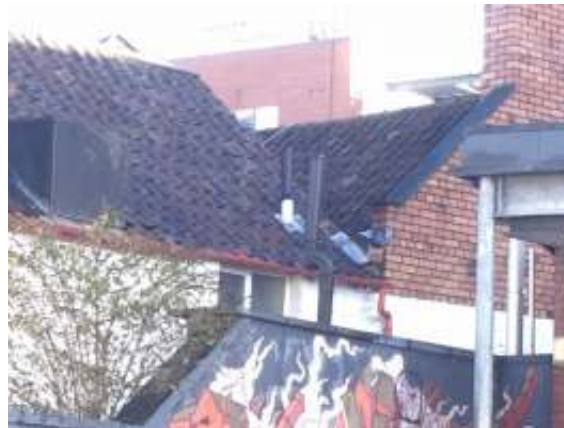
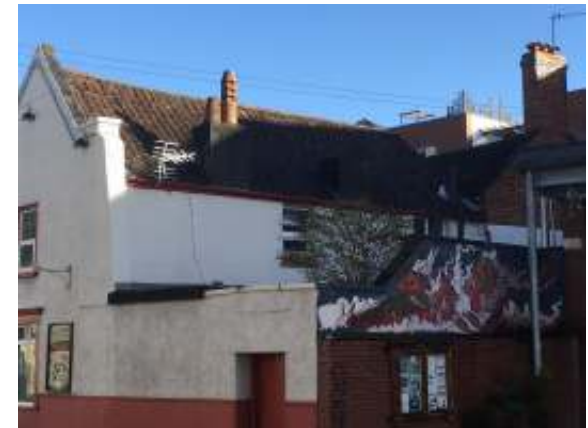
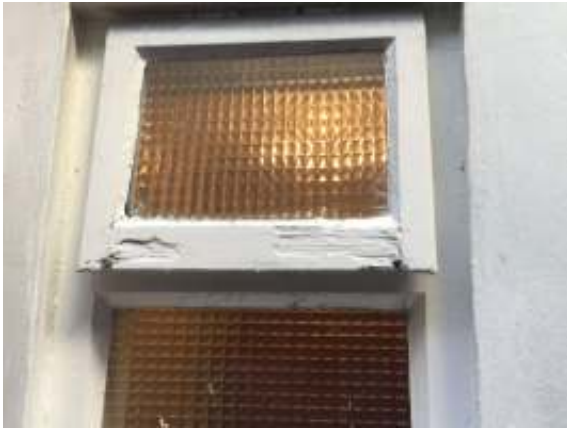
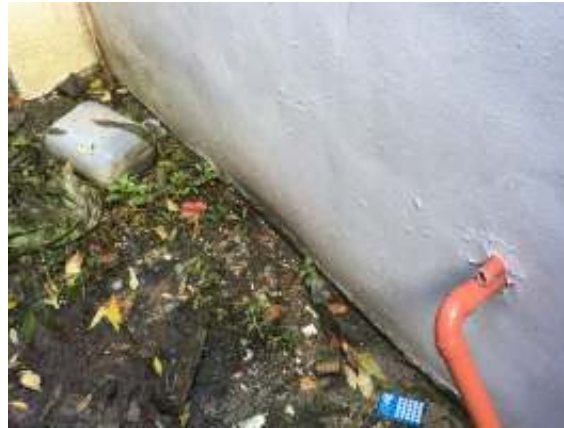
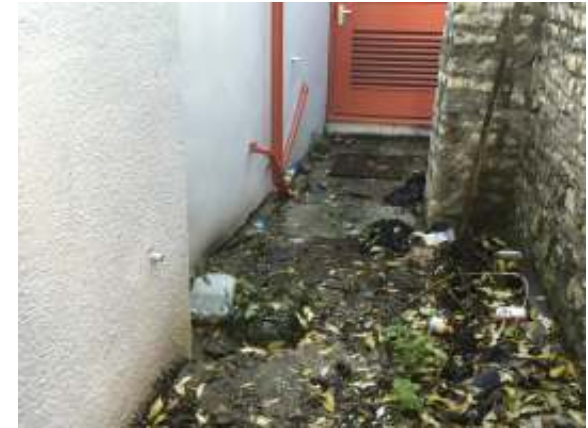
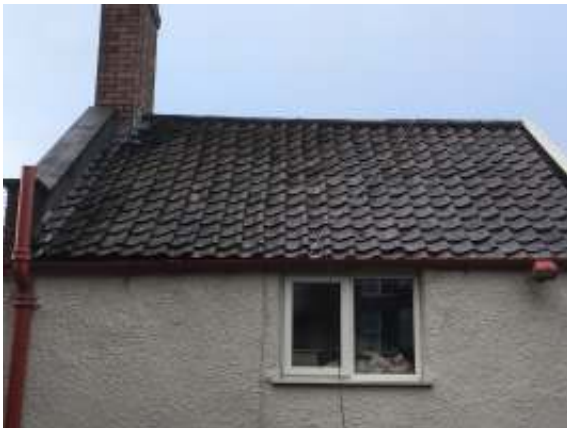
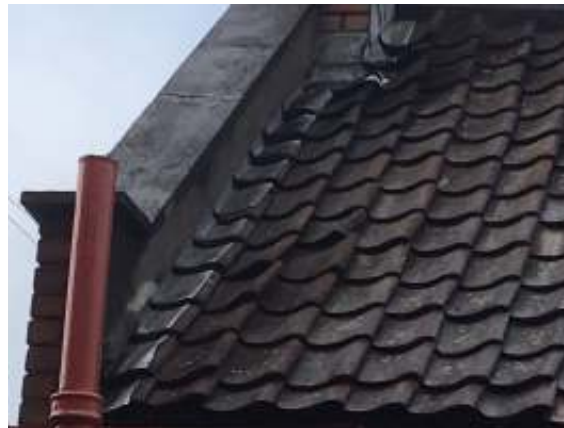
2.14.2	Rainwater Goods	Painted metal gutters and downpipe.	Poor Condition - Guttering poorly aligned with a build up of debris. Section of guttering too short allowing water to discharge over the copping stone to the top of the wall and flow down the wall where it abuts the external wall of the ladies toilet.

2.14.3	Roof	Multiple pitched roofs, one with clay tiles and one unseen. Flat roof with mineralised felt covering.	Satisfactory Condition - section of flat roof feels like the wooden deck may have moisture ingress.

2.14.4	Walls	Solid masonry wall with brick facing, render finishes and painted decoration.	Poor Condition - render cracked, with some sections loose and eroded at low level allowing water penetration.

2.14.5	Joinery	Double glazed plastic framed windows to the first floor. Single glazed timber windows, timber panel door and timber gate with painted decoration	Satisfactory Condition - paint flaking to woodwork exposing timber.

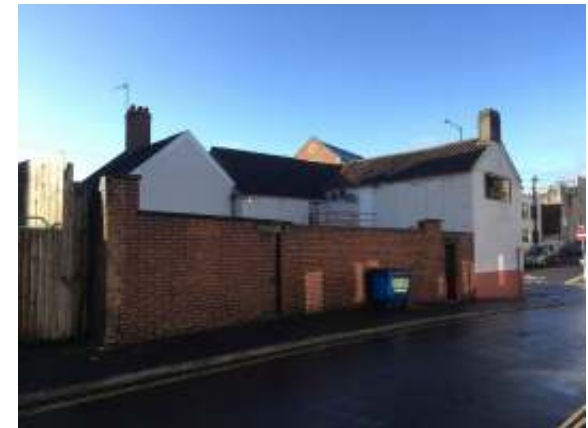
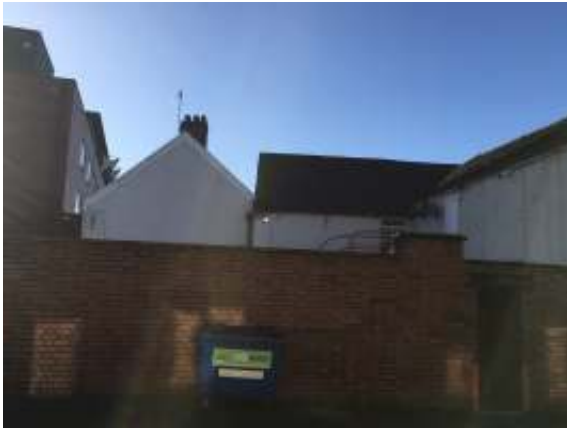
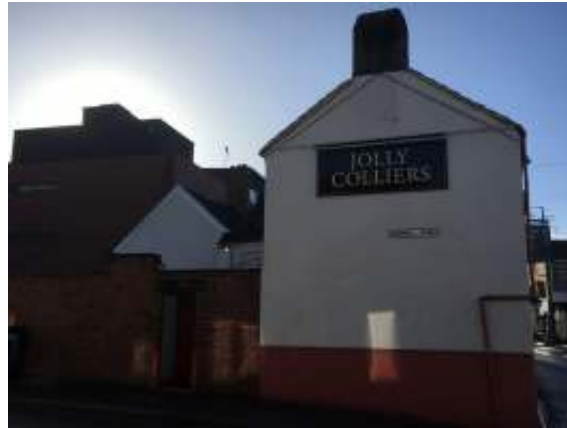
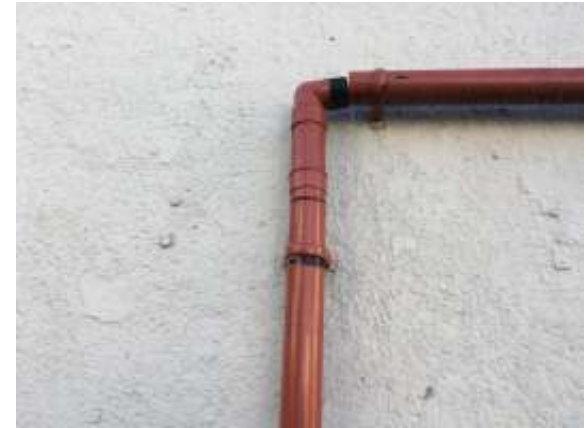
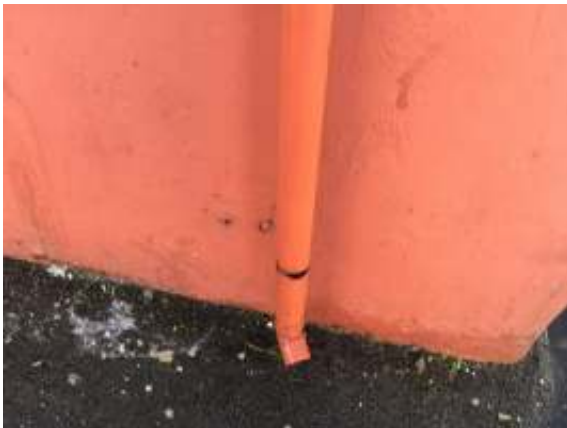
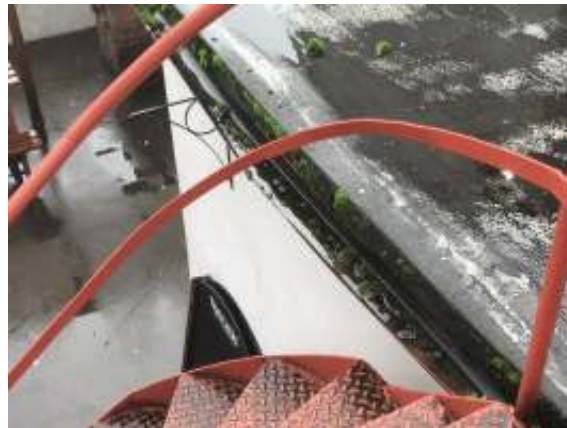
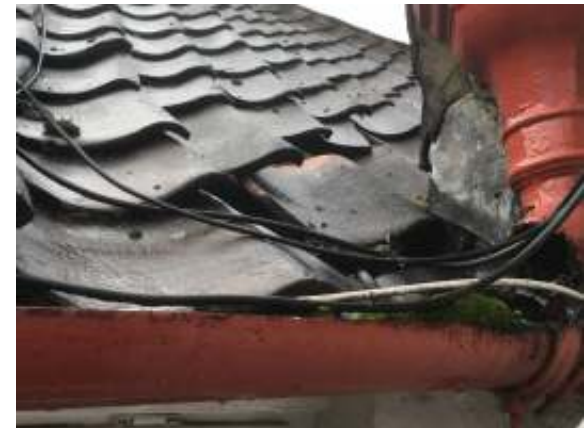
2.15	Left Elevation		Photographs [55-61]					
2.15.1	Chimney	Brick built chimney with brick facing and rendered finish with clay pots.	Satisfactory Condition - cracking to render.

2.15.2	Rainwater Goods	Painted metal gutters and downpipes. Painted plastic gutters and downpipes.	Poor Condition - 1No section of downpipe come detached and not secured to the wall. Guttering poorly aligned with a build up of debris.

2.15.3	Roof	Multiple pitched roofs, one with clay tiles and two unseen. Flat roof with mineralised felt covering.	Satisfactory Condition - some tiles missing/slipped.

2.15.4	Walls	Solid masonry wall with render finishes and painted decoration.	Poor Condition - render cracked, with some sections loose and eroded at low level allowing water penetration.

2.15.5	Joinery	Double glazed plastic framed windows to the first floor. Single glazed timber windows, timber framed french doors with painted decoration	Satisfactory Condition - paint flaking to woodwork exposing timber.

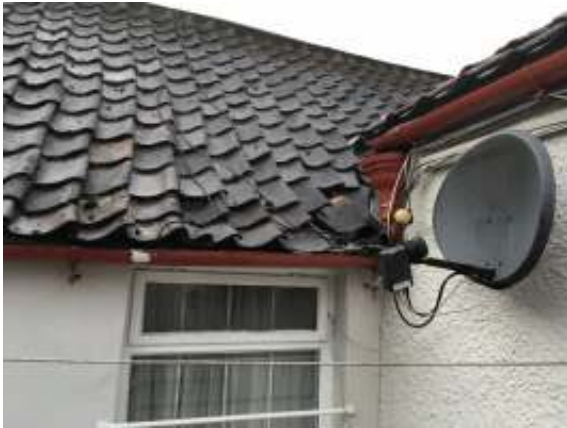
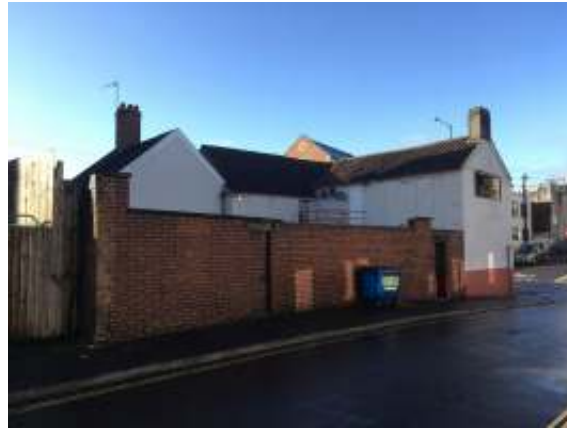
2.16.2	Rainwater Goods	Painted metal gutters and downpipe.	Poor Condition - Guttering poorly aligned with a build up of debris.					
2.16.3	Roof	Multiple pitched roofs, one with clay tiles and one unseen. Flat roof with mineralised felt covering.	Satisfactory Condition

2.16.4	Walls	Solid masonry wall with render finishes and painted decoration.	Poor Condition - render cracked, with some sections loose and eroded at low level allowing water penetration.

2.16.5	Joinery	Double glazed plastic framed windows and solid UPVC door to the first floor. Single glazed timber windows, timber panel door with painted decoration	Satisfactory Condition - paint flaking to woodwork exposing timber.
