Schedule of Condition

Painters Arms
51 Cross Street
Cowes
PO31 7TA

17th March 2018

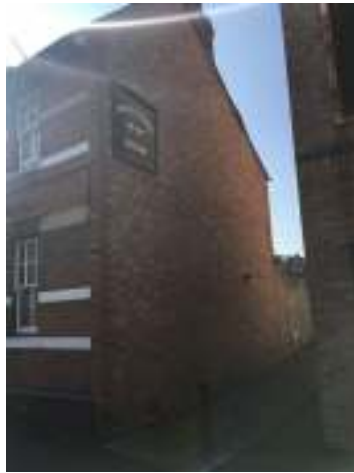
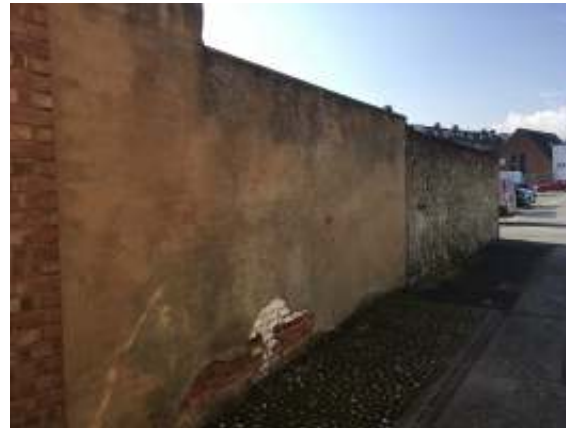
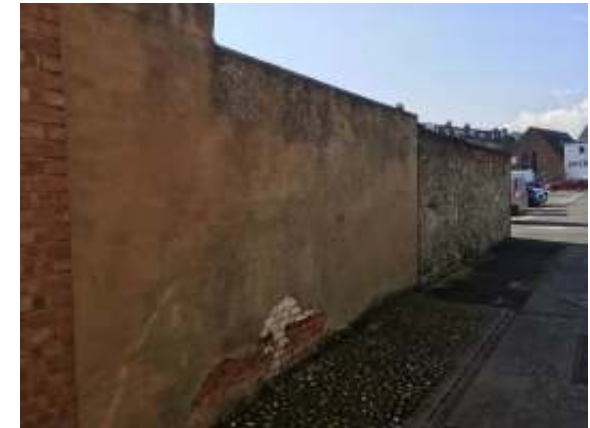
1.1	Rear elevation		Photographs [2-4]					
1.1.1	Walls	Solid masonry walls with brick finishes and brick masonry boundary wall with part render.	Satisfactory Condition - patch of damaged bricks and render noted.

1.1.2	Chimney	Brick chimney stack with clay pots.	Satisfactory Condition -					
1.2	Right elevation		Photographs [5-11]					
1.2.1	Chimney	Brick chimney stack with clay pots and metal flashing.	Satisfactory Condition -

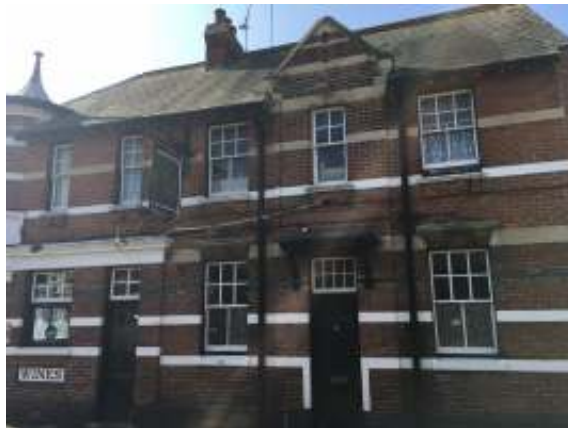
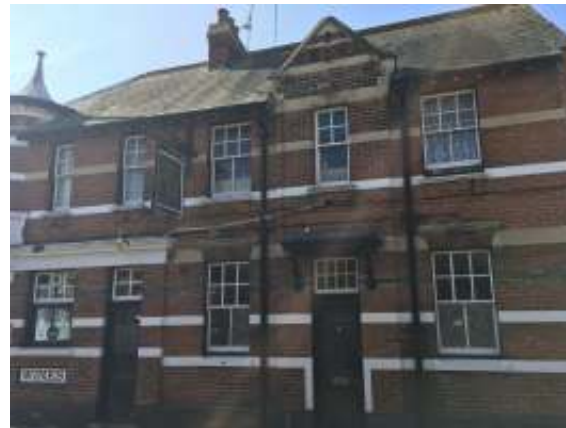
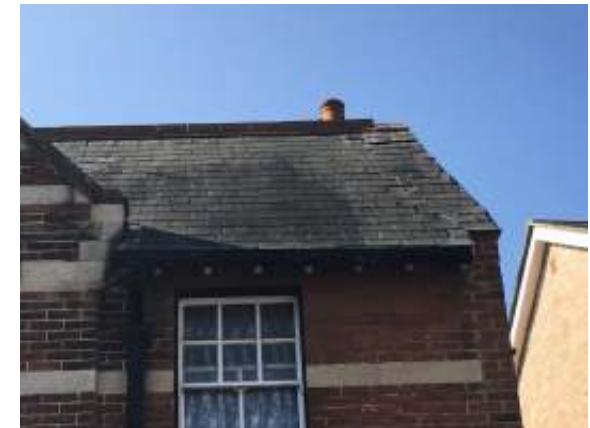
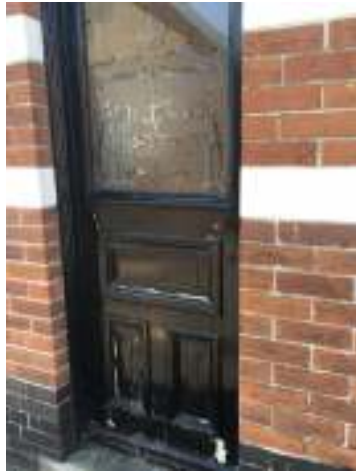
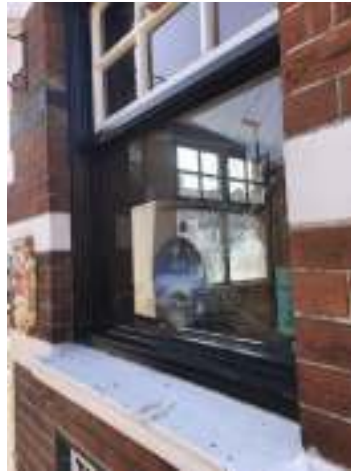
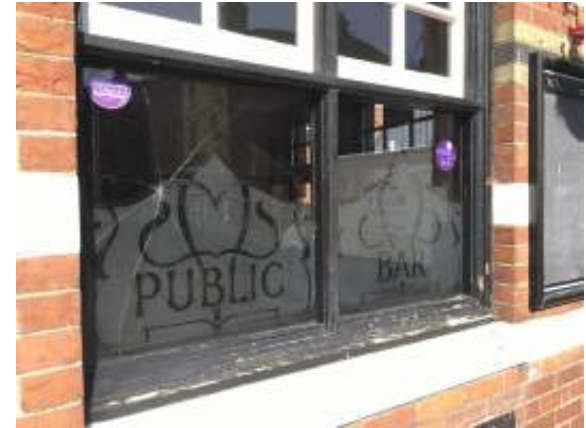
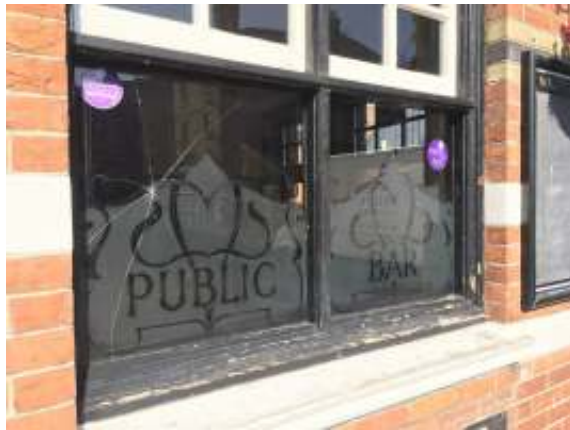
1.2.2	Roof	Pitched and hipped roof with slate tile finishes and metallic flashing.	Satisfactory Condition - slates slipping to rear right hand verge.

1.2.3	Rainwater Goods	Painted metallic gutters and downpipes.	Satisfactory condition although no formal test of these items have been undertaken by us. -

1.2.4	Walls	Solid masonry walls with brick finishes, rendered masonry and corbel details.	Satisfactory Condition -					
1.2.5	Joinery	Single glazed timber windows, timber doors, fascia and soffit boards with painted decorations.	Satisfactory Condition - some glass broken.

1.2.6	Miscellaneous	Mixed external lighting and illuminated pub signage.	Satisfactory condition although no formal test of these items have been undertaken by us. - pub signage timber frame rotting.

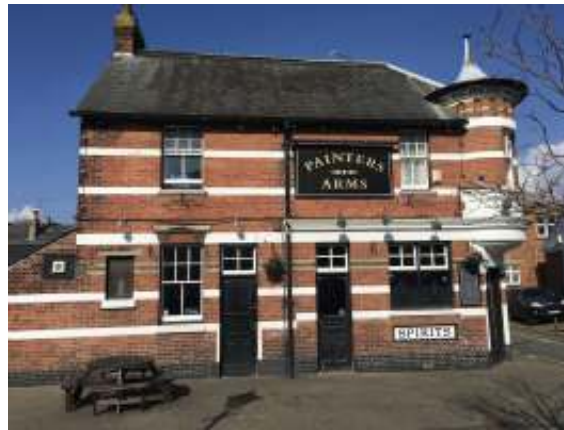
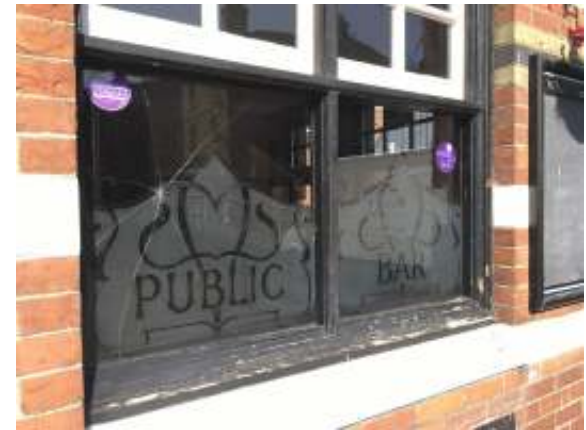
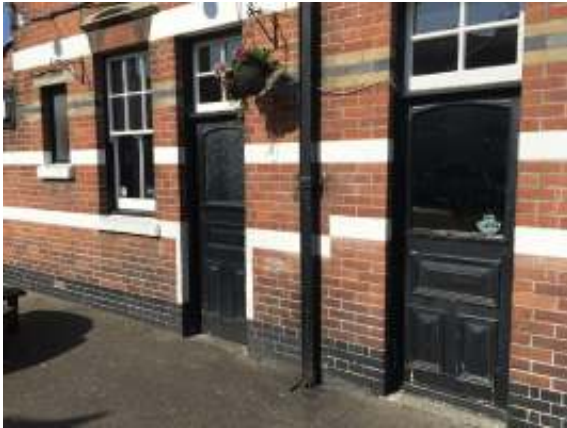
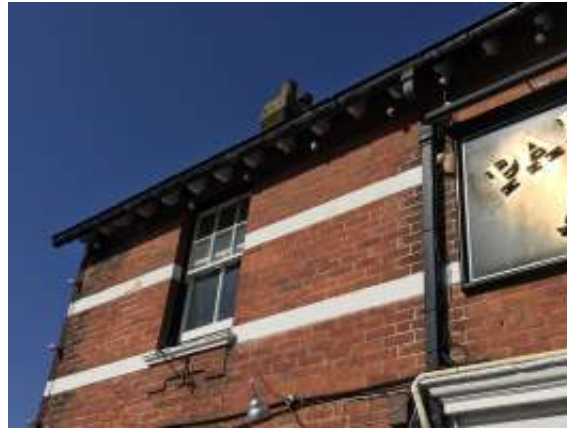
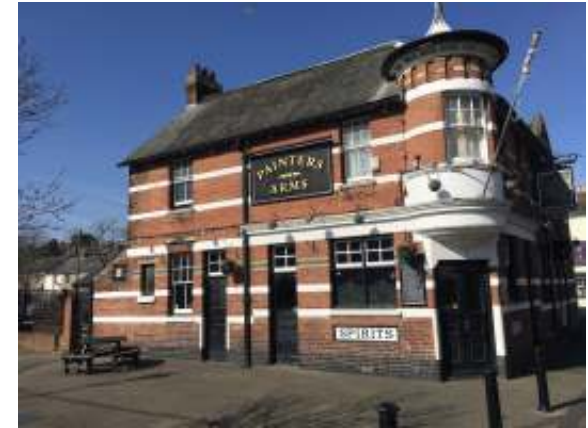
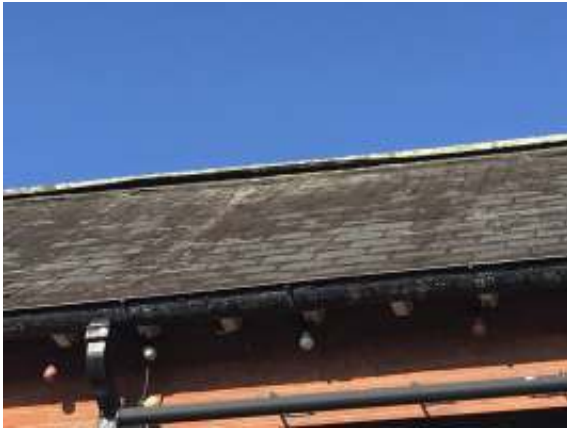
1.3	Front elevation		Photographs [12-17]					
1.3.1	Chimney	Brick chimney stack with clay pots and metal flashing.	Satisfactory Condition -					
1.3.2	Roof	Pitched and hipped roof with slate tile finishes and metallic flashing.	Satisfactory Condition - flashing to ridge warped, and tiles slipped.

1.3.3	Rainwater Goods	Painted metallic gutters and downpipes.	Satisfactory condition although no formal test of these items have been undertaken by us. -

1.3.4	Walls	Solid masonry walls with brick finishes, rendered masonry and corbel details.	Satisfactory Condition -					
1.3.5	Joinery	Single glazed timber windows, timber doors, fascia and soffit boards with painted decorations.	Satisfactory Condition -

1.3.6	Miscellaneous	Mixed external lighting and illuminated pub signage.	Satisfactory condition although no formal test of these items have been undertaken by us. -

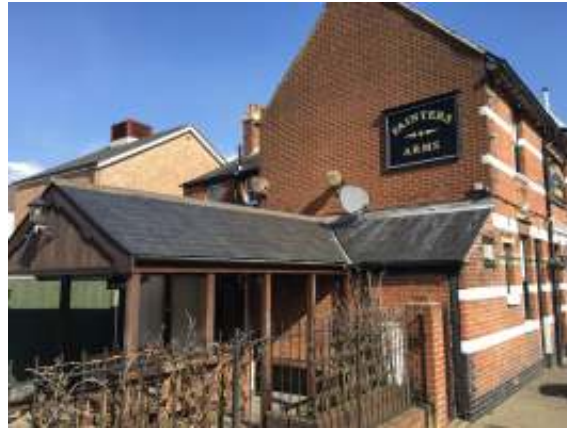
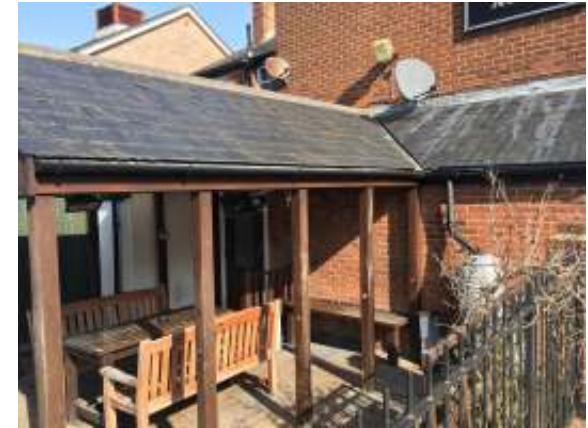
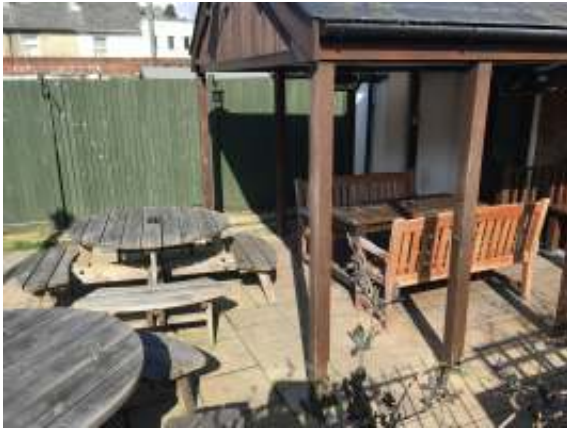
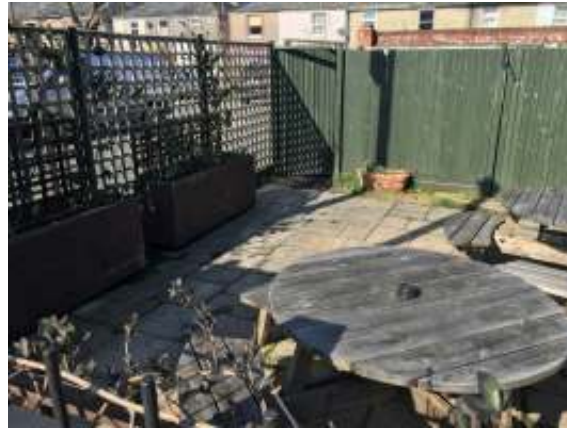
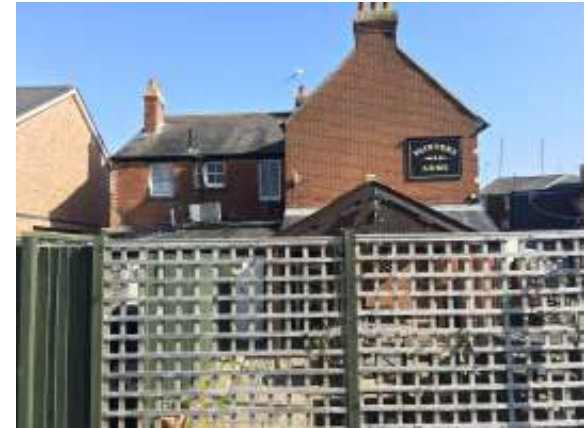
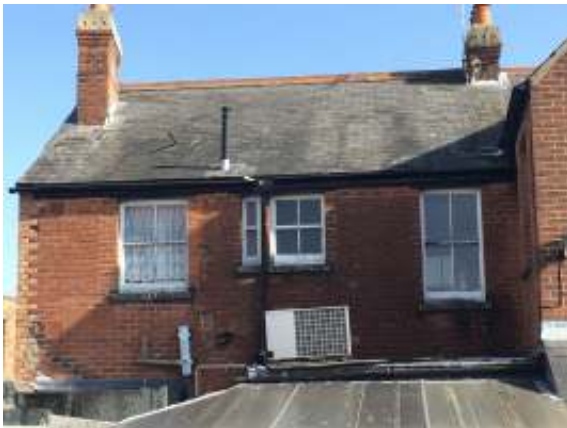
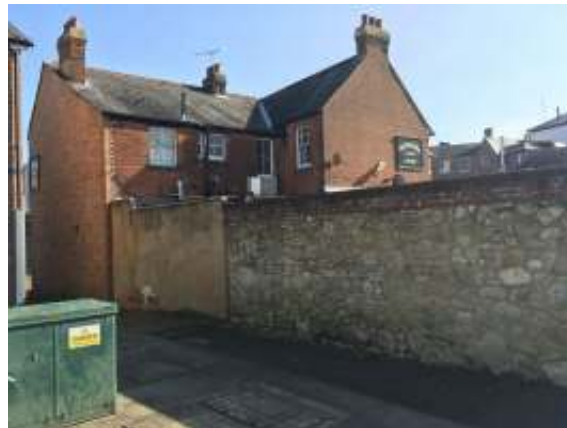
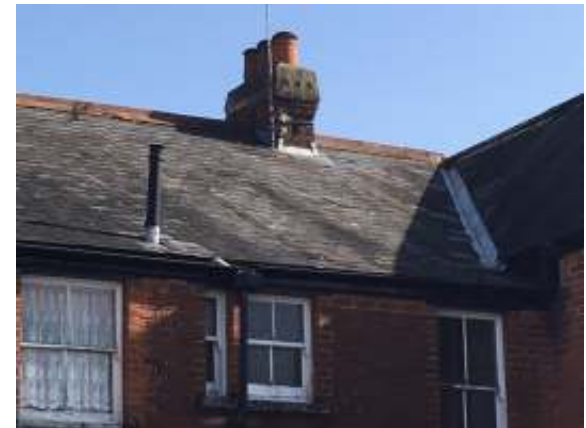
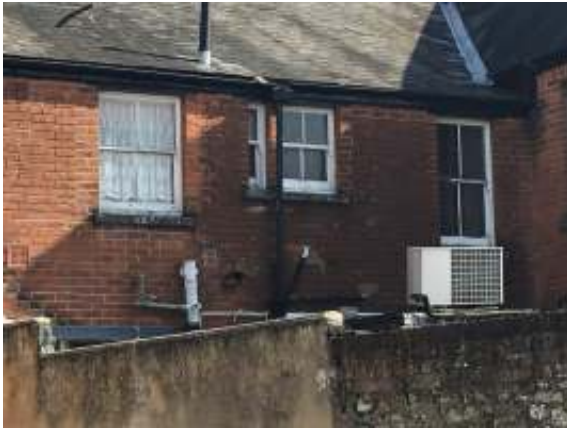
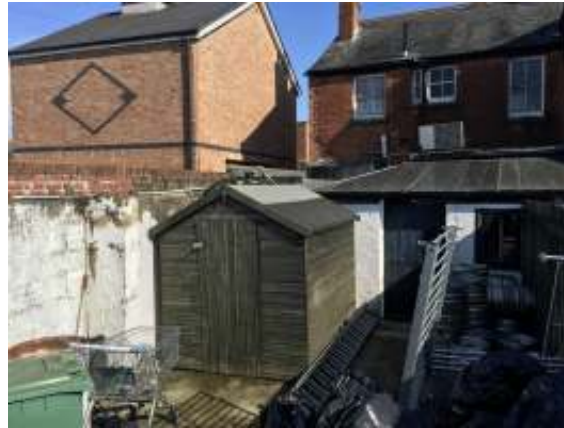
1.4	Left elevation		Photographs [18-27]					
1.4.1	Chimney	Solid masonry chimney stacks with clay pots and metal flashing.	Satisfactory Condition -

1.4.2	Roof	Pitched and hipped roof with slate tile finishes and metallic flashing. Single storey flat roofing provided with felt and plastic covering.	Satisfactory Condition - slipped slates noted to valley and verges.

1.4.3	Rainwater Goods	Painted metallic gutters and downpipes.	Satisfactory condition although no formal test of these items have been undertaken by us. -

1.4.4	Walls	Solid masonry walls with brick finishes, rendered masonry and corbel details.	Satisfactory Condition -					
1.4.5	Joinery	Single glazed timber windows, timber doors, fascia and soffit boards with painted decorations.	Satisfactory Condition -

1.4.6	Miscellaneous	Mixed external lighting and illuminated pub signage.	Satisfactory condition although no formal test of these items have been undertaken by us. -

1.4.7	Grounds	Concrete finished yard with timber fencing, brick boundary and gates, beer garden paved with timber fencing and metal railings.	Satisfactory Condition - brick masonry to boundary wall damaged.					
2	Internal

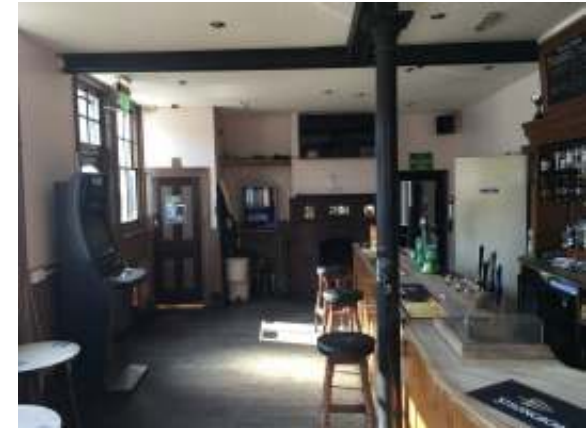
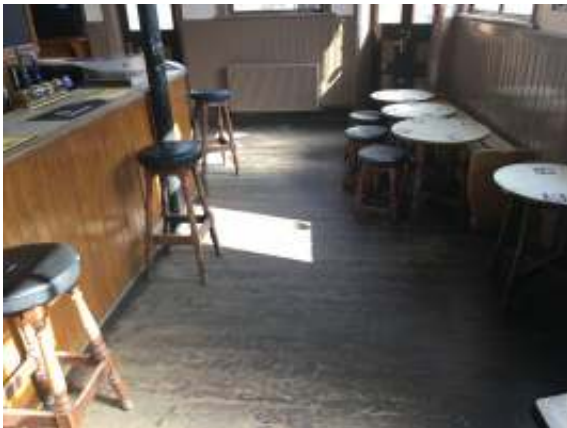
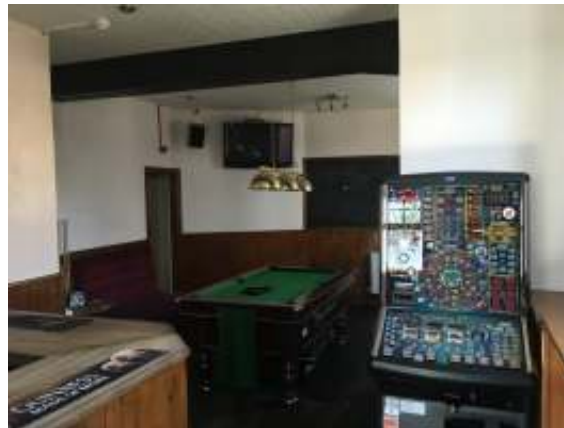
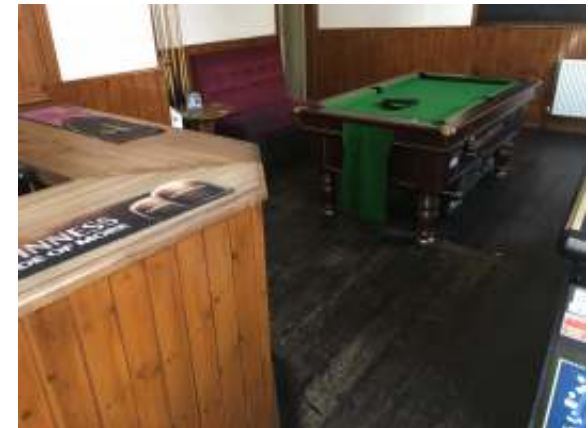
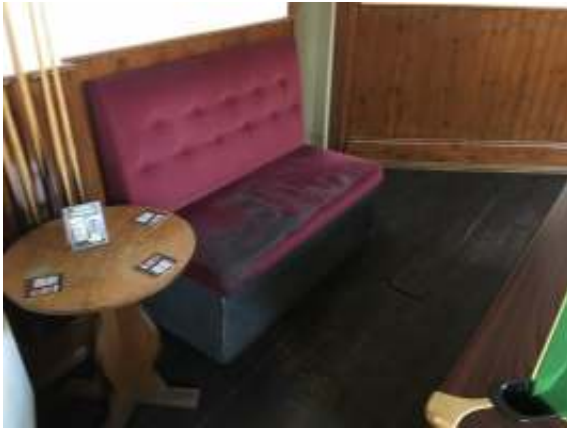
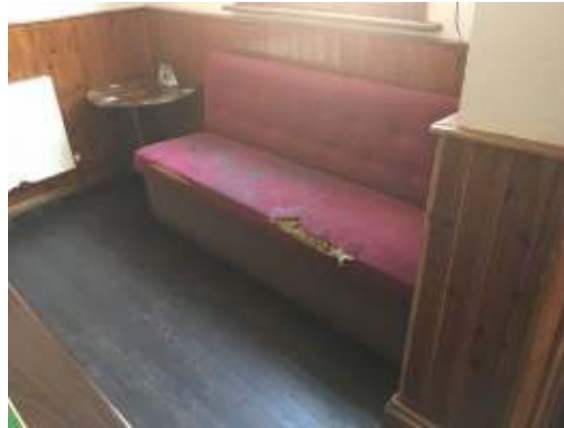
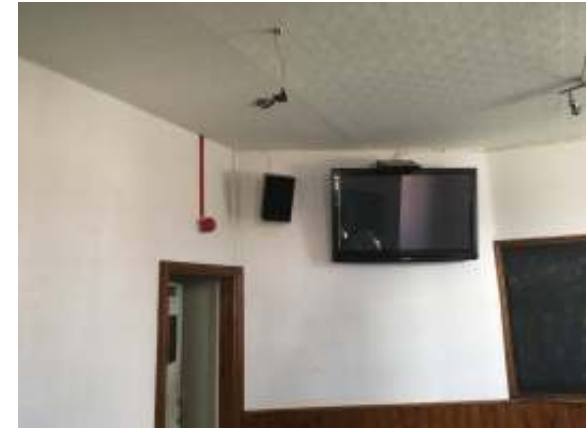
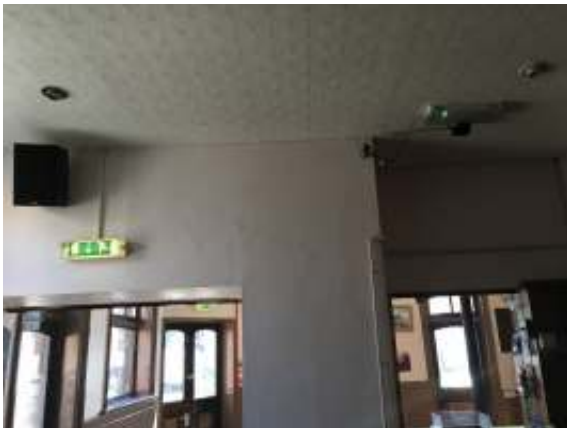
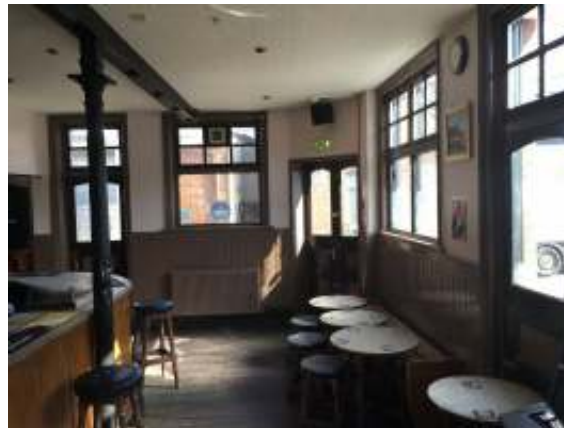
2.5	Main bar	Photographs [28-36]						
2.5.1	Ceilings	Lath and plaster ceiling, fully decorated including, lining paper and water based paint, oil based paint.	Satisfactory Condition -

2.5.2	Walls	Solid masonry walls and partitions with, plaster finishes, timber panelling, lining paper and mixed decorations.	Satisfactory Condition -

2.5.3	Floors	Suspended timber floor, timber boarding and vinyl flooring.	Satisfactory Condition -

2.5.4	Joinery	Single glazed timber windows, timber doors, frames, skirting boards, bar unit and back bar fittings.	Satisfactory Condition -					
2.5.5	Miscellaneous	Emergency lighting, smoke detection, call point, wall mounted TV, speakers, switch gear, cables, fixed seating.	Satisfactory condition although no formal test of these items have been undertaken by us. - fixed seating fabric deteriorated.

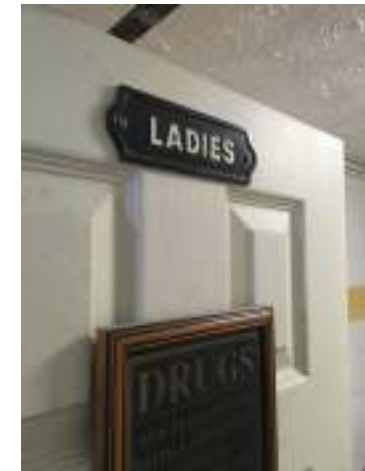
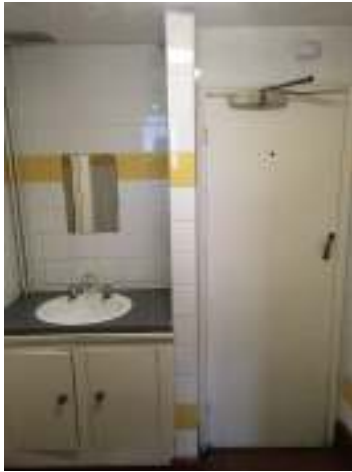
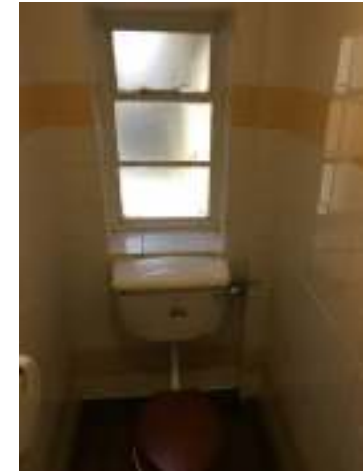
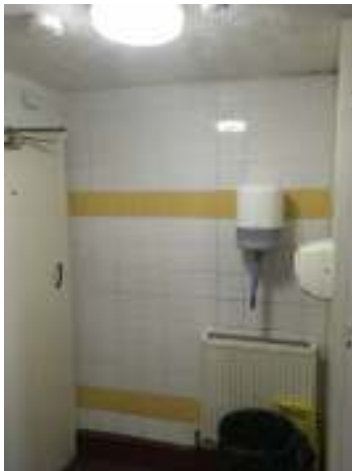
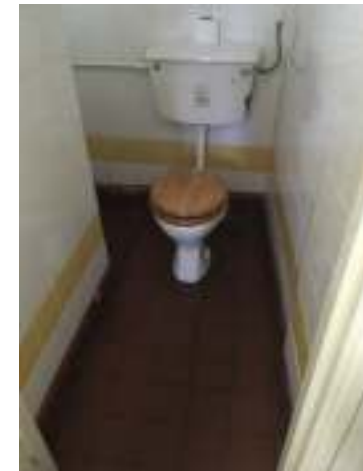
2.6	Ladies toilets		Photographs [37-43]					
2.6.1	Ceilings	Plasterboard ceiling , fully decorated including, lining paper and water based paint, oil based paint.	Satisfactory Condition -

2.6.2	Walls	Mixed timber stud partitions and masonry walls with, plaster finishes, paint decoration and ceramic tiling.	Satisfactory Condition -					
2.6.3	Floors	Solid concrete floor and vinyl flooring.	Satisfactory Condition -

2.6.4	Joinery	Timber non fire rated door, timber panel door, skirting boards, architraves and reported items fully decorated.	Satisfactory Condition -

2.6.5	Miscellaneous	Bulk head light fittings, ceramic bathroom suite, emergency light.	Satisfactory condition although no formal test of these items have been undertaken by us. -

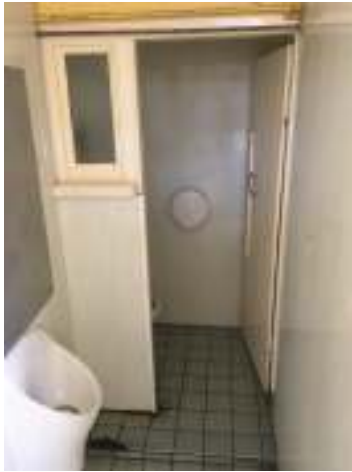
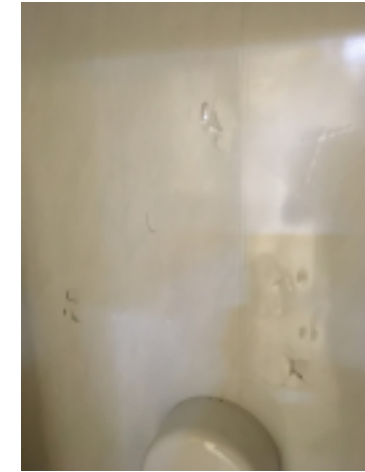
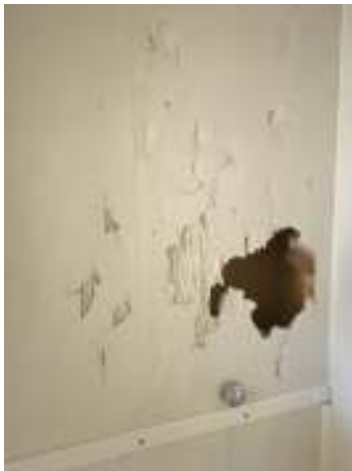
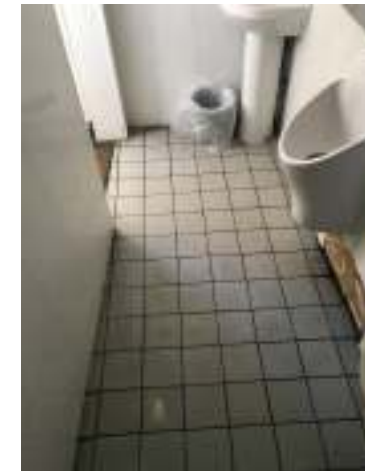
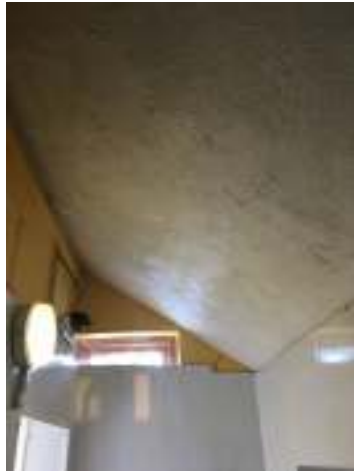
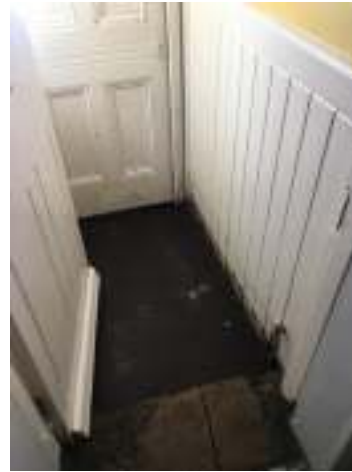
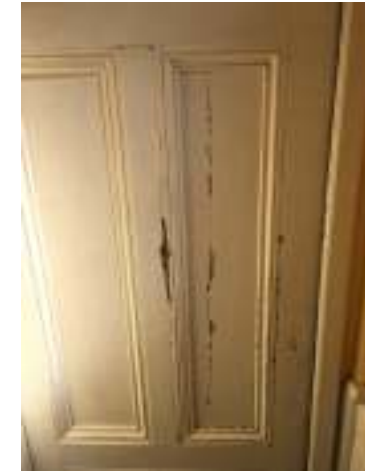
2.7	Gents toilets		Photographs [44-52]					
2.7.1	Ceilings	lath and plaster ceiling, fully decorated including, lining paper and water based paint, oil based paint.	Satisfactory Condition -

2.7.2	Walls	solid masonry walls and partitions with, plaster finishes, plastic cladding, lining paper and paint decoration.	Satisfactory Condition - plastic clad wall sections damaged.

2.7.3	Floors	solid concrete floor and ceramic tiling.	Satisfactory Condition - some tiles broken.					
2.7.4	Joinery	Single glazed timber windows, timber doors and frames with painted decorations.	Satisfactory Condition - split timber door insets.

2.7.5	Miscellaneous	Emergency light fitting, bulkhead light, ceramic bathroom suite.	Satisfactory condition although no formal test of these items have been undertaken by us. -

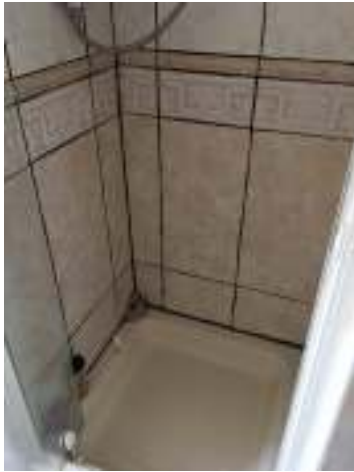
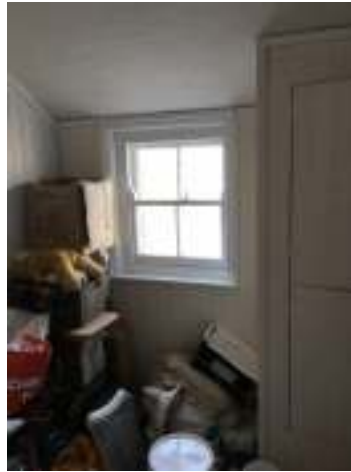
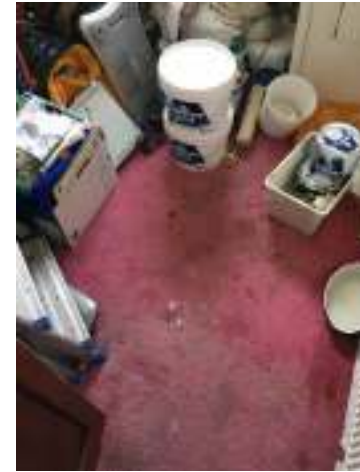
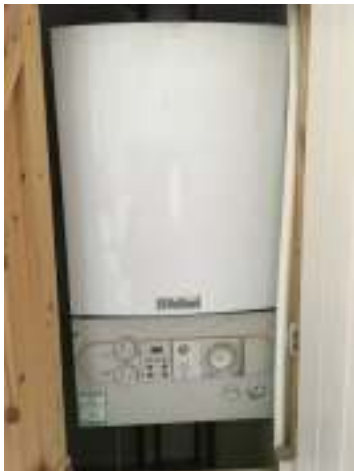
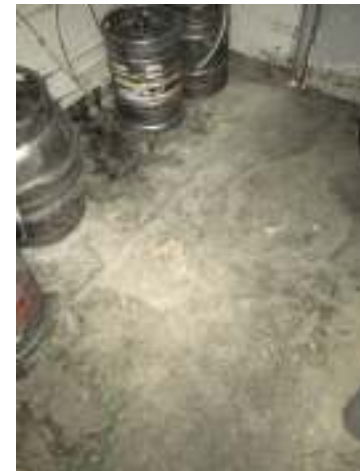
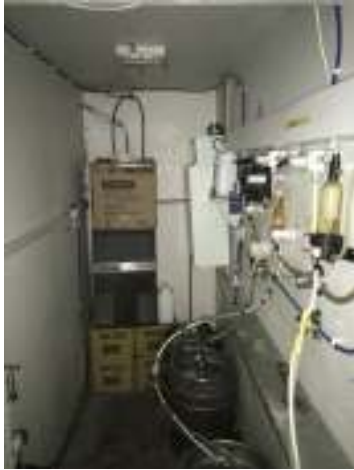
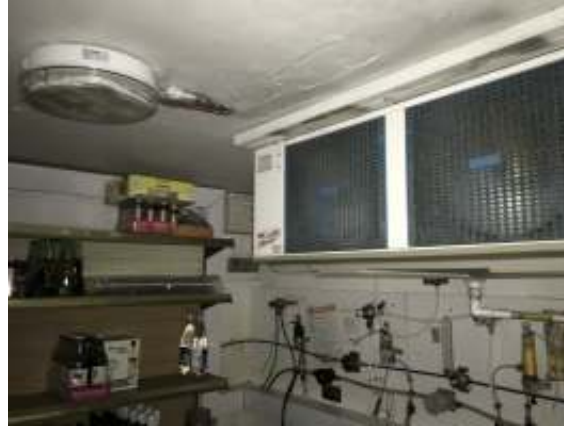
2.13	Bedroom (rear left)		Photographs [69-71]					
2.13.1	Ceilings	Plaster ceiling fully decorated.	Satisfactory Condition -

2.13.2	Walls	Mixed solid masonry and timber stud walls with plaster finishes, and timber cladding.	Satisfactory Condition -					
2.13.3	Floors	Suspended timber floor with carpet finishes.	Satisfactory Condition - stained carpet.

2.13.4	Joinery	Timber panelled doors, single glazed window, skirting and architrave joinery.	Satisfactory Condition -					
2.13.5	Miscellaneous	Gas boiler, pendant lights, switches and sockets.	Satisfactory condition although no formal test of these items have been undertaken by us. -

2.14	Cellar		Photographs [72-75]					
2.14.1	Ceilings	Plaster ceiling with painted decorations.	Satisfactory Condition -					
2.14.2	Walls	Solid painted masonry with plaster finishes.	Satisfactory Condition -

2.14.3	Floors	Solid concrete floor.	Satisfactory Condition -					
2.14.4	Joinery	Timber doors, frames and painted decorations.	Satisfactory Condition -

2.14.5	Miscellaneous	Air cooling unit, bulkhead lights.	Satisfactory condition although no formal test of these items have been undertaken by us. -
